ROADSTER HUB 10,25 connectivity and Blackscreen issue - 142655

Some vehicles might lose the ability to play music through bluetooth or have a black screen displayed

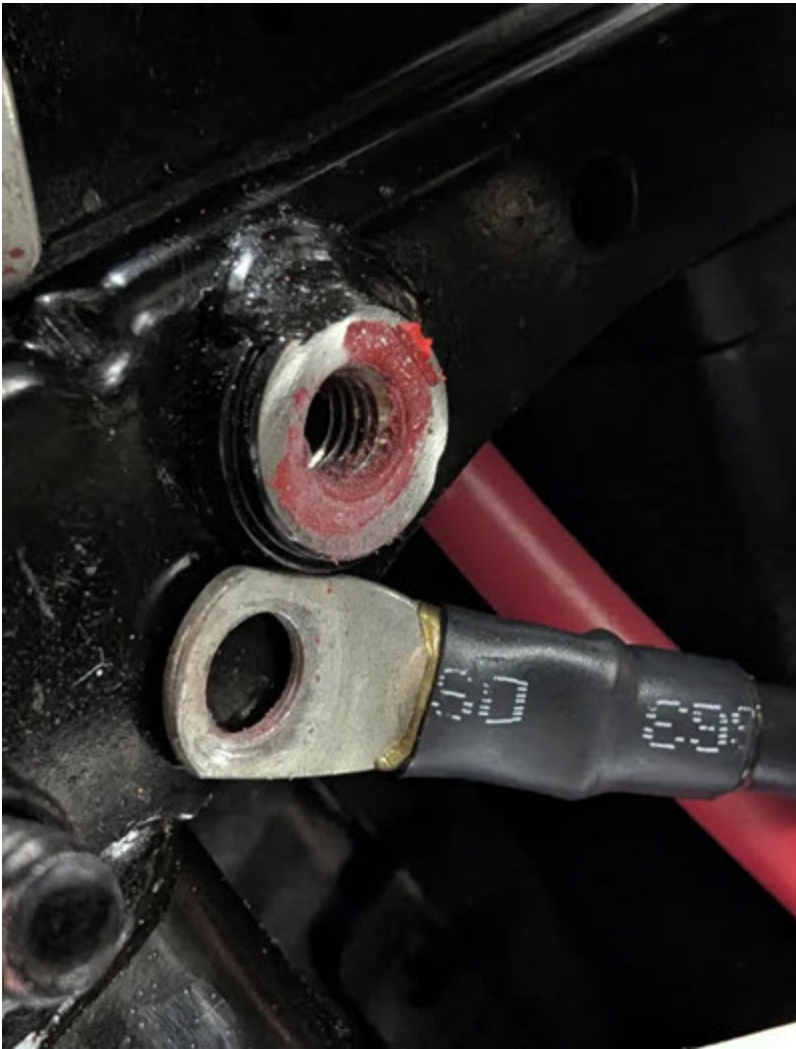
- If Bluetooth issue persist, gather information of the application in use, Phone Model and OS version when it stopped working.
- Connect headset with Bluetooth before connecting the phone with the USB cord
- **Only** the headset should be paired with the cluster via Bluetooth
- Parts replacement will not help with Bluetooth issues
- Refer to Bulletin [Troubleshooting_Guide for 10.25 in Touchscreen Display](#) for more information on the supported devices
- If black screen persist, please inspect engine ground for melted ScotchGrip

If the HCM ventilation procedure is not available please open technical case for guidance

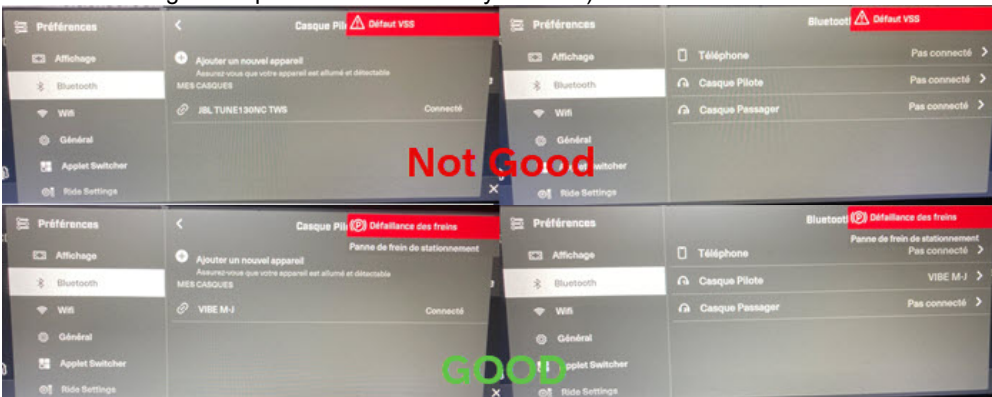
For **Apple Carplay** to work, the headset must be visible in both Bluetooth screen menus in order to connect (its possible that a headset meeting the requirements will not fully connect)
