GROUP	MODEL
	ENG	2026MY K5 (DL3) w/ 2.5 GDI Theta III
	NUMBER	DATE
	265	March 2026

## TECHNICAL SERVICE BULLETIN

### SERVICE ACTION: THETA III 2.5 GDI ECM SW LOGIC IMPROVEMENT (SA642)

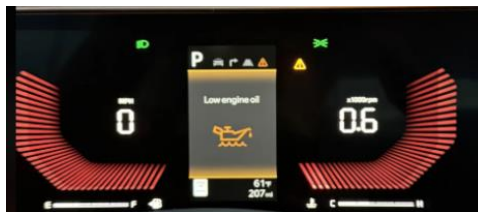
#### DTC Description:

P250F00 - Engine Oil Level Too Low
