GROUP	MODEL
BOD	2021-2025MY Sorento (MQ4a) <u>and</u> 2021-2025MY Sorento Hybrid (MQ4 HEV) <u>and</u> 2022-2025MY Sorento Plug-in Hybrid (MQ4 PHEV)
NUMBER	DATE
351	March 2026

## TECHNICAL SERVICE BULLETIN

SUBJECT: **HORN ASSEMBLY INSPECTION AND REPLACEMENT (WTY042)**

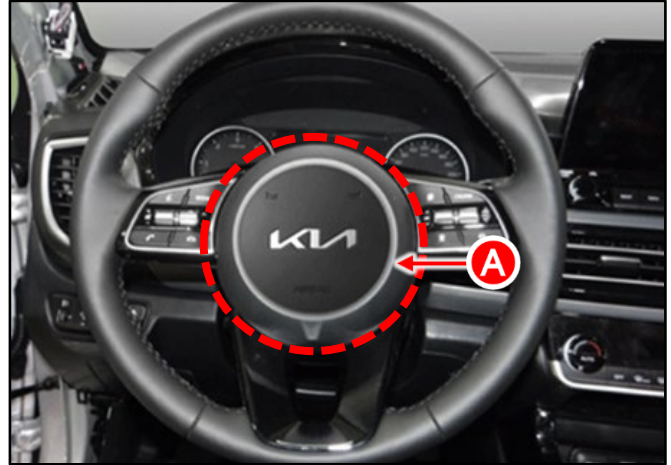
- Press the Horn Pad (A) to confirm normal operation.
  - If the horn operates **normally**, this TSB does not apply. **Claim inspection only Labor Op Codes 262001R0 or 252A6110.**

If the horn is **inoperative** or the **tone is distorted**, proceed to the 'Replacement Procedure' below.

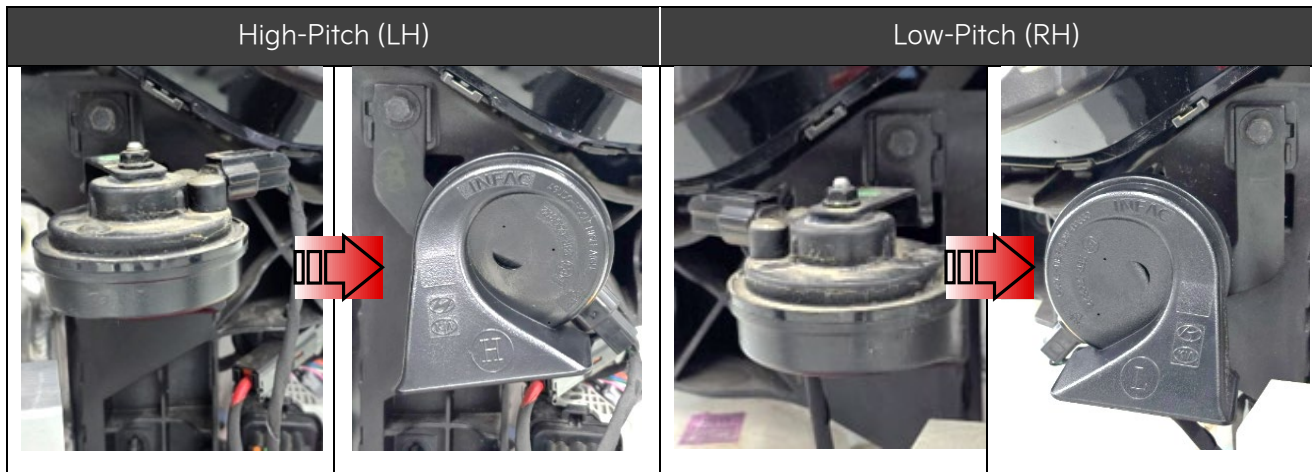
For 24-25MY MQ4a and 25MY MQ4 P/HEV, the replacement horns will install in a vertical orientation, which differs from the original mounting position.

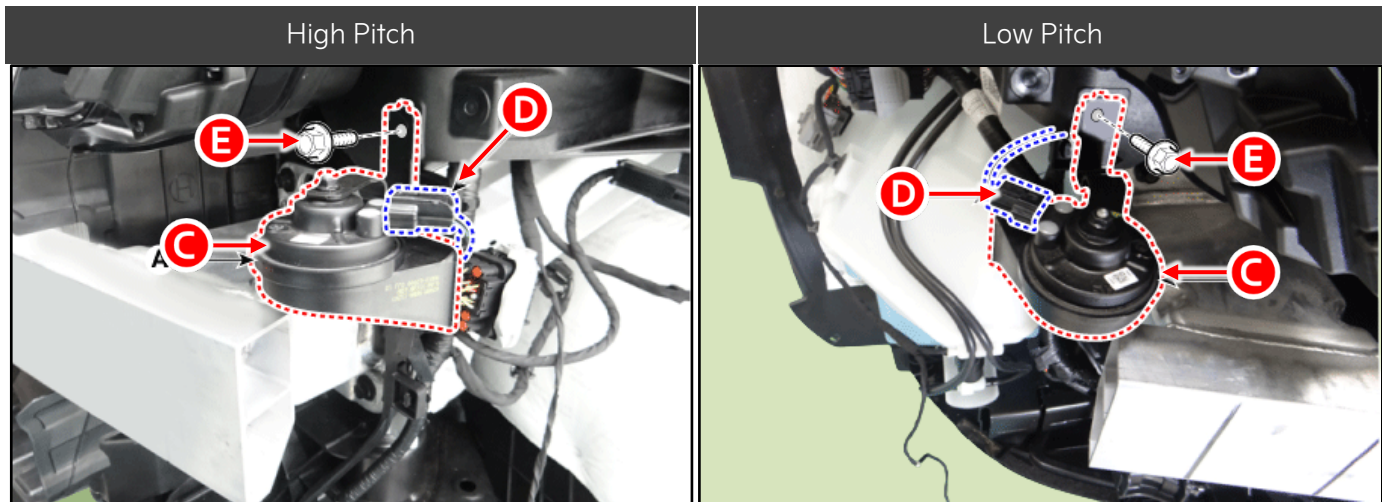
This bulletin provides information associated with the 'Warranty Extension Program' (WTY042) to inspect and, if necessary, replace the horn assembly on certain vehicles listed in the table below. The affected vehicles may experience an unusual or different horn sound than normal, or an inoperative horn, caused by corrosion inside the electric horn and/or carbonization of the contact point. The warranty coverage for repairs related to the horn assembly has been extended from 5 years / 60,000 miles to 10 years / 120,000 miles, whichever comes first, starting from the date the vehicle was first put into service. Follow the procedure outlined in this publication to inspect and, if necessary, replace both the high-pitch and low-pitch horn assemblies with new ones.

- Replace the low pitch and high pitch horns (C) after disconnecting the horn connector (D) and removing bolt (E) by referring to "Body Electrical System → Horn → Repair procedures" in the applicable Shop Manual on KGIS.

**Tightening torque for nut/bolt (E):**  
8.2 - 9.0 lb.ft (11.1 - 12.3 N.m)
