Technical Service Bulletin (TSB)
Flash: Radio Frequency Hub Module (RFHM) Updates

REFERENCE:	TSB: 08-139-26 GROUP: 08 - Electrical	Date:	March 28, 2026	REVISION:	–
VEHICLES AFFECTED:	2026 (DT) RAM 1500 Pickup This bulletin applies to vehicles built on or before January 19, 2026 (MDH 0119XX) equipped with Proximity Approach/Departure Lamps (Sales Code LNR).			MARKET APPLICABILITY: <input checked="" type="checkbox"/> NA <input checked="" type="checkbox"/> MEA <input checked="" type="checkbox"/> SA <input type="checkbox"/> IAP <input checked="" type="checkbox"/> EE <input type="checkbox"/> CH NOTE: This bulletin applies to Middle East & Africa, North and South America and Enlarged Europe markets.	
CUSTOMER SYMPTOM:	Customer may experience the following: <ul style="list-style-type: none"> 12V vehicle battery dies if keys are left within proximity range. 				
CAUSE:	RFHM software

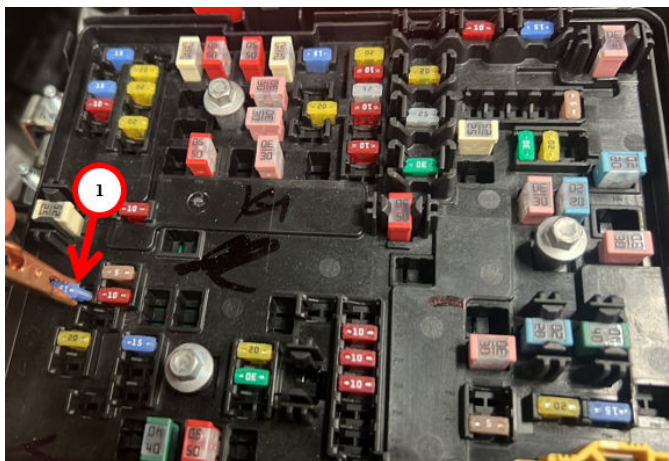
1 - F08 MOD Cluster Fuse

Fig. 1
F08 MOD Cluster Fuse Location

3. Remove fuse F08 MOD CLUSTER from the underhood Power Distribution Center (PDC) [Fig. 1](#).
