Technical Service Bulletin (TSB)
Flash: Radio Frequency Hub Module (RFHM) Updates

REFERENCE:	TSB: 08-140-26 GROUP: 08 - Electrical	Date:	March 28, 2026	REVISION:	08-232-25 REV. C
VEHICLES AFFECTED:	2025 (DT) RAM 1500 Pickup This bulletin applies to vehicles **equipped with Proximity Approach/ Departure Lamps (Sales Code LNR)** .			MARKET APPLICABILITY: <input checked="" type="checkbox"/> NA <input checked="" type="checkbox"/> MEA <input checked="" type="checkbox"/> SA <input checked="" type="checkbox"/> IAP <input type="checkbox"/> EE <input type="checkbox"/> CH NOTE: This bulletin applies to Middle East & Africa, North and South America and India & Asia Pacific markets.	
CUSTOMER SYMPTOM:	Customer may experience one or more of the following: <ul style="list-style-type: none"> ● **12V vehicle battery dies if keys are left within proximity range (NA vehicles only)**. ● RFHM software update fails when attempting to perform a flash. ● Low vehicle battery. ● Key fob is inoperable. ● Proximity is inoperable.

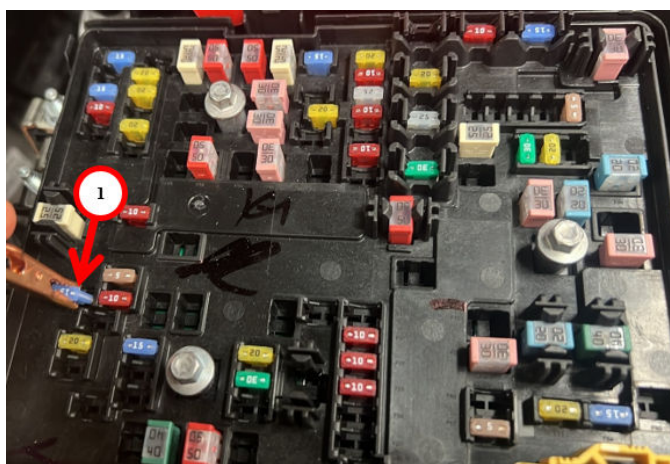
Fig. 1
F08 MOD Cluster Fuse Location

1 - F08 MOD Cluster Fuse

1. Is this vehicle on the RSU VIN list?
 - YES >>> Proceed to [Step 2](#).
 - NO >>> Proceed to [Step 3](#).
2. Does the RFHM have the latest software already installed?
 - YES >>> This bulletin has been completed. Use Inspect LOP **** (18-19-12-BF) **** to close the active RSU.
 - NO >>> Proceed to [Step 3](#).
3. Remove fuse F08 MOD CLUSTER from the underhood Power Distribution Center (PDC) [Fig. 1](#).
