REFERENCE:	TSB: 23-008-26 GROUP: 23 - Body	Date:	March 24, 2026	REVISION:	—
VEHICLES AFFECTED:	2026 (DT) RAM 1500 Pickup This bulletin applies to vehicles built on or after August 11, 2025 (MDH 0811XX) and on or before October 02, 2025 (MDH 1002XX) equipped with Grille-Surr 3 Body Color Tex 2 Black (Sales Code MFX) or Grille-Surr 3 Black Texture 2 Black (Sales Code MFS) with Surround View Camera System (Sales Code XAK).	MARKET APPLICABILITY:			
		<input checked="" type="checkbox"/> NA <input type="checkbox"/> MEA <input type="checkbox"/> SA <input type="checkbox"/> IAP <input type="checkbox"/> EE <input type="checkbox"/> CH NOTE: This bulletin applies to the North America markets.			
CUSTOMER SYMPTOM:	Customers may comment on the following: <ul style="list-style-type: none"> The grille on the vehicle is chrome but should be black Fig. 1. 				
CAUSE:	Manufacturing issue

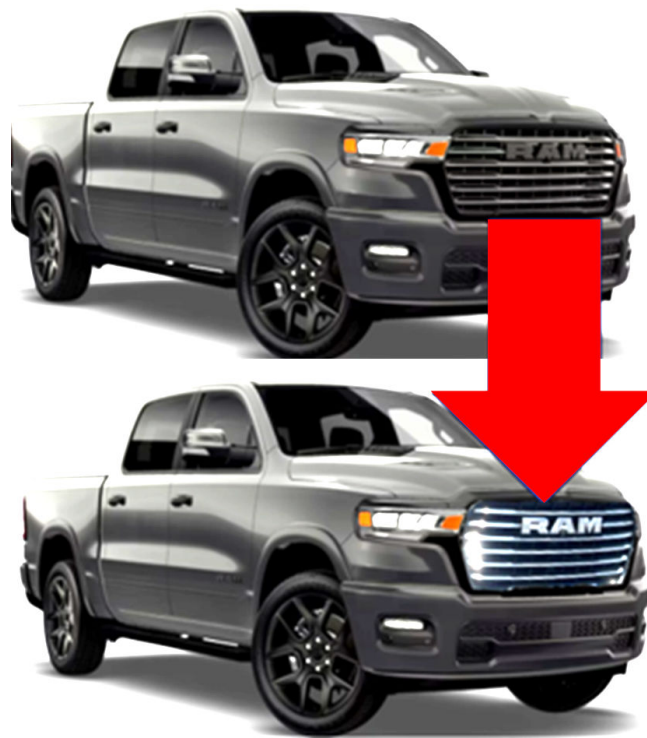
Fig. 1
Correct Black Grille And Incorrect Chrome Grille

This bulletin involves inspecting and possibly replacing the grille and nameplate.

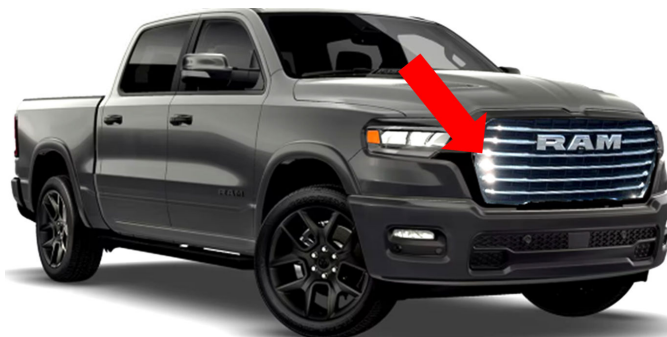
**Fig. 2**

1. Is the color of the grilles horizontal bars chrome [Fig. 2](#)?
 - YES >>> Proceed to [Step 2](#).
 - NO >>> Use Inspect LOP (23-02-01-9D) to close the active RSU.

Incorrect Grille With Chrome Horizontal Inserts

2. Replace the grille. Refer to the detailed procedures available in DealerCONNECT > Service Library > under: 23 - Body / Exterior / Grille / Removal and Installation.
3. Using the existing nameplate speed nuts, install the new nameplate to the grille.
