<b>REFERENCE:</b>	<b>TSB:</b> 24-002-26 <b>GROUP:</b> 24 - Heating and Air Conditioning	<b>Date:</b>	March 27, 2026	<b>REVISION:</b>	—
<b>VEHICLES AFFECTED:</b>	<b>2025 (FG) FIAT 500e</b> This bulletin applies to vehicles built on or after July 01, 2025 (MDH 0701XX) and on or before December 06, 2025 (MDH 1206XX).	<b>MARKET APPLICABILITY:</b>		<input checked="" type="checkbox"/> NA <input type="checkbox"/> MEA <input type="checkbox"/> SA <input type="checkbox"/> IAP <input type="checkbox"/> EE <input type="checkbox"/> CH <b>NOTE:</b> This bulletin applies to North America markets.	
<b>CUSTOMER SYMPTOM:</b>	<b>The customer may comment on the following:</b> <ul style="list-style-type: none"> <li>Automatic air conditioning starts to flow cold air even if hot temperature is set.</li> </ul>				
<b>CAUSE:</b>	Sponge on cabin temperature sensor

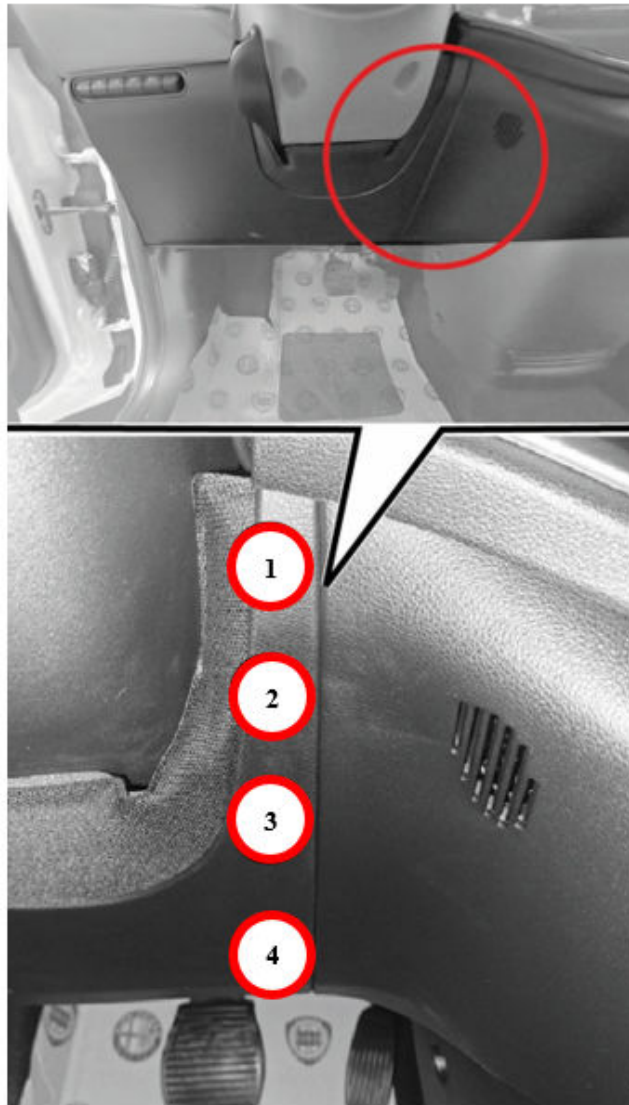
**Fig. 1**  
Dashboard Trim

- 1 - Trim Panel Act Location
  - 2 - Trim Panel Act Location
  - 3 - Trim Panel Act Location
  - 4 - Trim Panel Act Location
-

1. Enter the vehicle from the driver's side.
2. Release the dashboard trim by pulling it downward.

3. Act on the indicated points shown in Fig. 1.

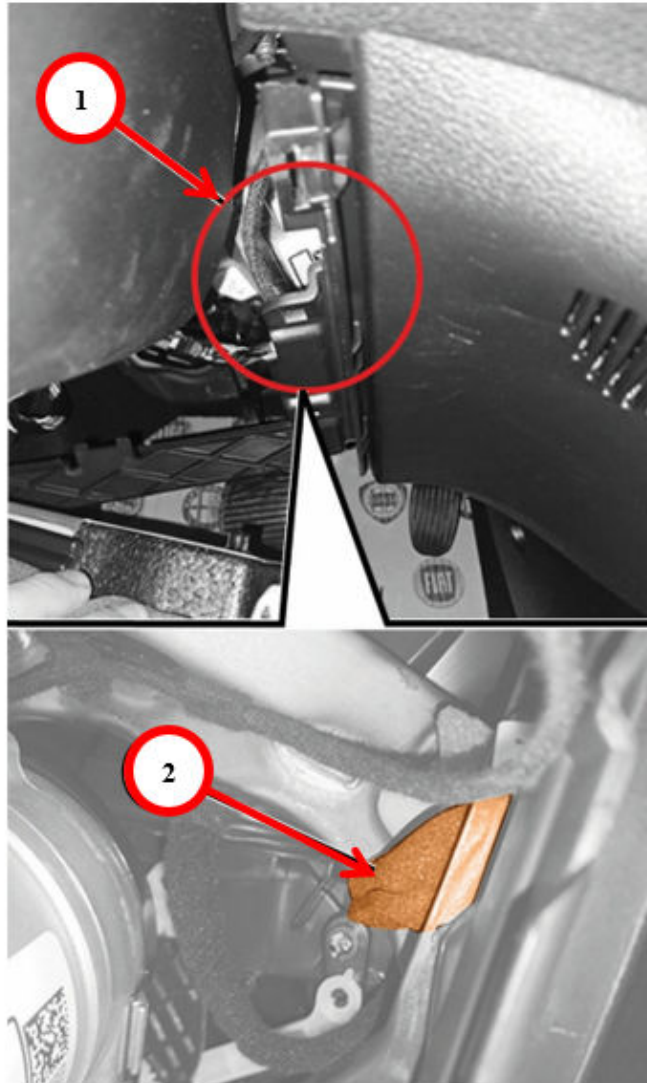
**Fig. 2**  
Sponge Location

- 1 - Open Space
- 2 - Sponge

4. Insert your hand inside the space [Fig. 2](#).

- 
5. Locate the sponge covering the sensor [Fig. 2](#).

6. Dislodge and remove the sponge [Fig. 2](#).

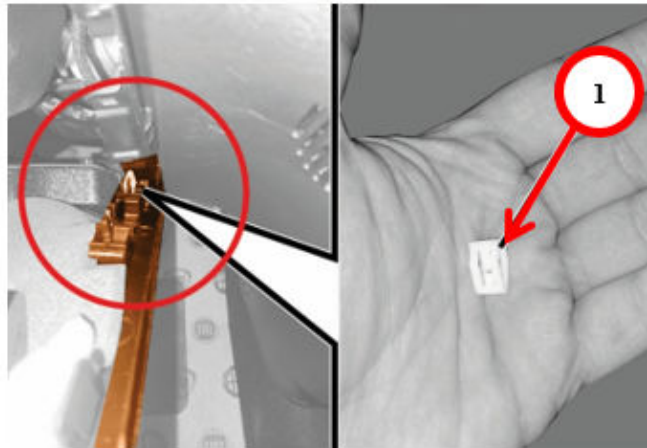
**Fig. 3**  
Clip Location

1 - Dislodged Clip

**NOTE:** If, during disassembly, a white clip becomes detached from the trim, it is necessary to restore it to its correct position on the tab before reassembly [Fig. 3](#).

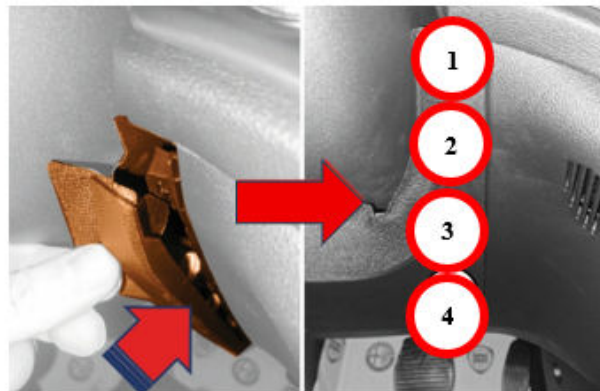
**Fig. 4**  
Restore Dashboard Trim

1 - Upper Clip Tab  
2 - Second Clip Tab  
3 - Third Clip Tab  
4 - Bottom Clip Tab

7. Restore the dashboard trim fastenings [Fig. 4](#).

8. Start from the upper tab [Fig. 4](#).  
9. Press on the trim while engaging the fastening clips at points [Fig. 4](#).  
10. Hand the vehicle back to the Customer.
