R1 Radio Restore Procedure After Software Update

DATE: March 31, 2026

SECTION: 08.71-1 (INFO-TELEMATICS SYSTEM).

MODELS: MY21+ all models equipped with R1 Radio, up to software version U39.19.

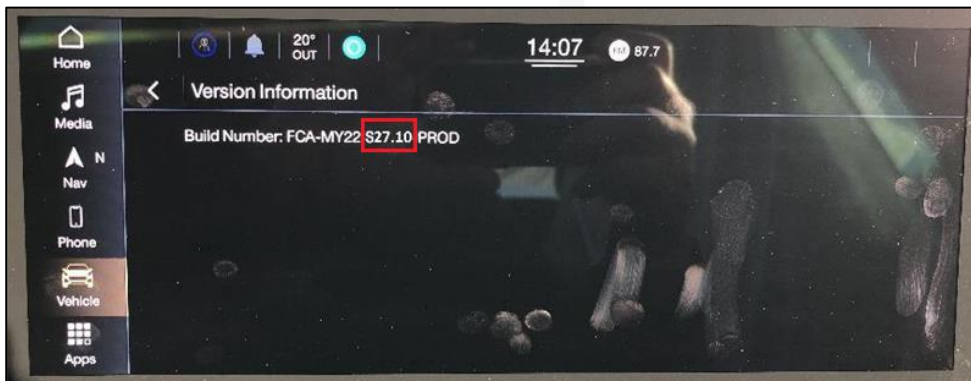
1. Check the Radio Software Version

Go to **System Information**.

1. If the version is **earlier than U39.19**, continue with the procedure.
2. If the version is **U39.19 or higher**, open a Blue-on-Line ticket.
