Diagnostic Sheet

FROM: Maserati TSO

Grecale MHEV – Turbocharger Inspection Procedure for Whistling Noise

DATE: March 25, 2026

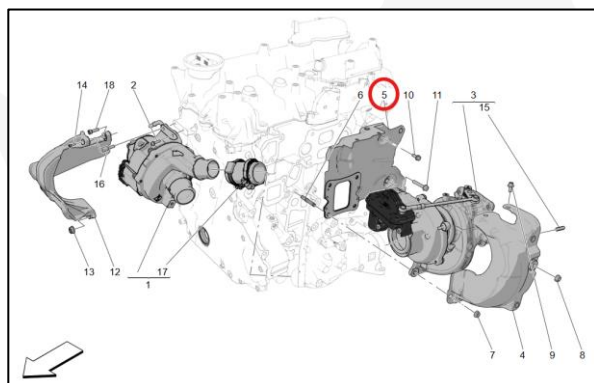
This bulletin provides guidance to the service network regarding the checks to be performed on the turbocharger when the only symptom reported is a whistling noise during acceleration. This communication originates from several cases where the noise was not caused by the turbocharger itself, but by the gasket located between the turbocharger and the cylinder head.

- High-frequency whistling noise during acceleration (refer to the video attached to this communication).
- Possible exhaust gas smell from the engine compartment area (rare occurrence).

2. Check for any presence of blue/white smoke from the exhaust.
3. Check for any traces of soot at the interface between the turbocharger and the cylinder head.
4. Remove the intake manifold according to procedure #01.40.059 and check whether the turbocharger shaft has excessive play or if the compressor/turbine blades show signs of damage:
 - a. If yes, it's likely that the turbo needs to be replaced; refer to the management of the components included in the Tutorship list.
 - b. If no, proceed with replacement of the heat shield and gasket (component #5 in Section #01.30-1 of the Spare Parts Catalogue).
