MAS005098 RU 26-07

# Rapid Update 816 GranTurismo –Trunk Lock Cover Check

DATE: March 31, 2026

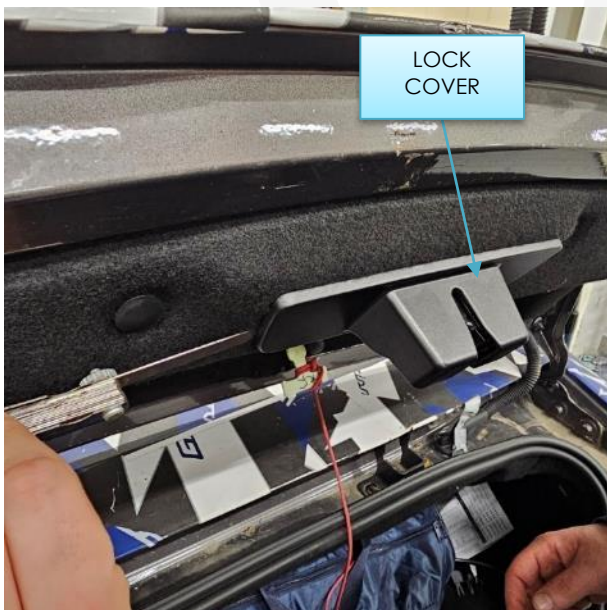
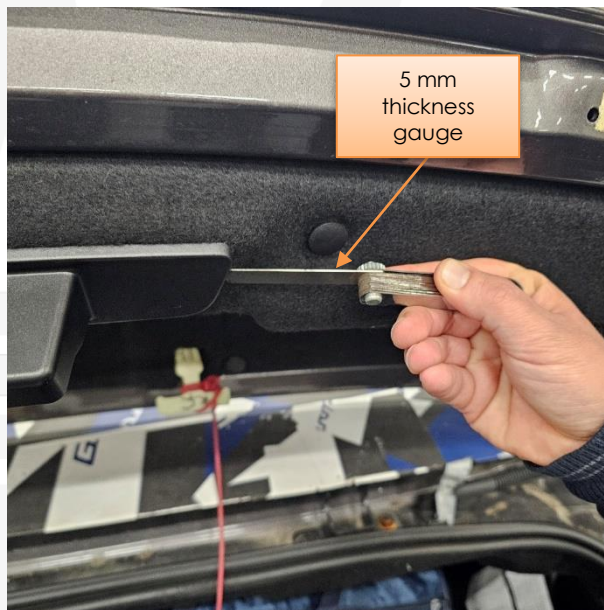
3. **After completing the stress cycle**, use a **5 mm feeler gauge** to check that the trunk lock cover is seated correctly around the entire perimeter.
  - **Note:** Do **not** force the feeler gauge between the cover and the trunk's interior trim. It should slide only if a gap naturally exists.
4. **If the 5 mm feeler gauge does not fit** between the cover and the interior trim (it stays on the outside), the vehicle is **compliant**.
  - No further action is required. The vehicle can be released.

5. **If the 5 mm feeler gauge does slide in** between the cover and the interior trim indicating a gap larger than 5 mm—the cover is **non-compliant (Not OK)**.
6. For non-compliant results, **replace the cover** following the procedure in the workshop manual:
  - Section **9.24.061 – Rear Hood Lock Cover: Removal/Refitting or Replacement**
7. Once the replacement is complete, the procedure is finished and the vehicle can be approved.
