GROUP	MODEL
ELE	2027MY Telluride (LQ2a)
NUMBER	DATE
415	March 2026

TECHNICAL SERVICE BULLETIN

SUBJECT: **REAR OCCUPANT ALERT LOGIC IMPROVEMENT (SA643)**

This issue number is [SA643](#).

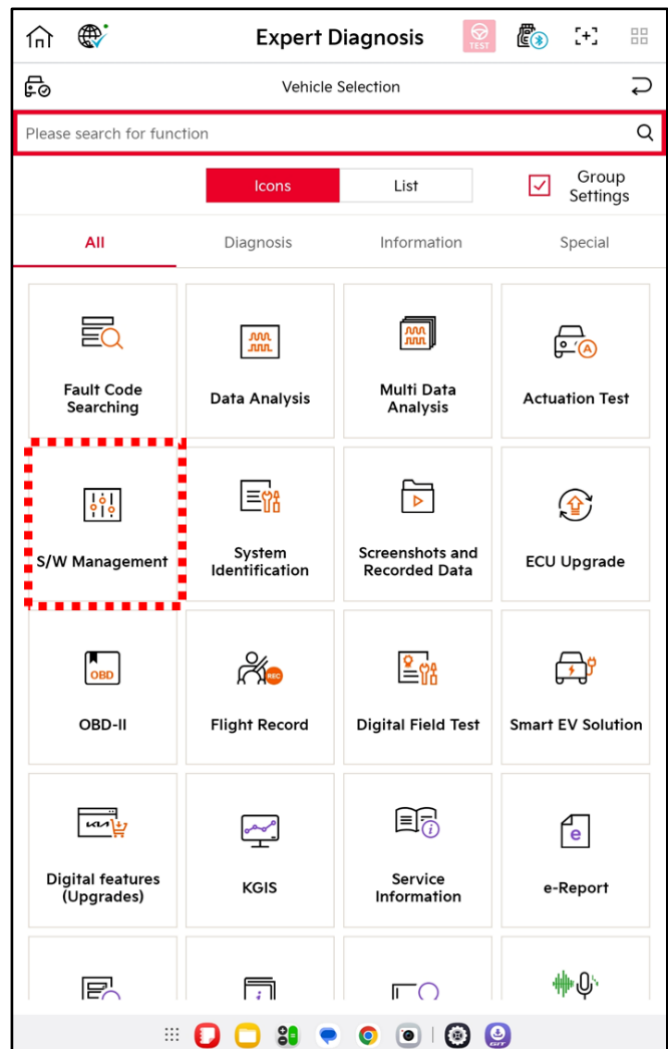
The update will not proceed if the ROA software version or part number do not match.

Information

The current ROA SW version does not meet the required version for this function.
Please update to version 26210 or higher and try again.

The current ROA part number is not supported for this function.
Please check the ECU specifications and try again.

1a. Using the KDS, select 'Expert Diagnosis'.

1b. Select 'S/W Management'.
