## Technical product information

<b>Topic</b>	Apple CarPlay - Intermittent Disconnection / WiFi Configuration Message
<b>Market area</b>	Bentley: worldwide (2WBE),China 796 VW Import Comp. Ltd (Vico), Beijing (6796)
<b>Brand</b>	Bentley
<b>Transaction No.</b>	2081219/1
<b>Level</b>	EH
<b>Status</b>	Released for publishing
<b>Release date</b>	March 4 2026

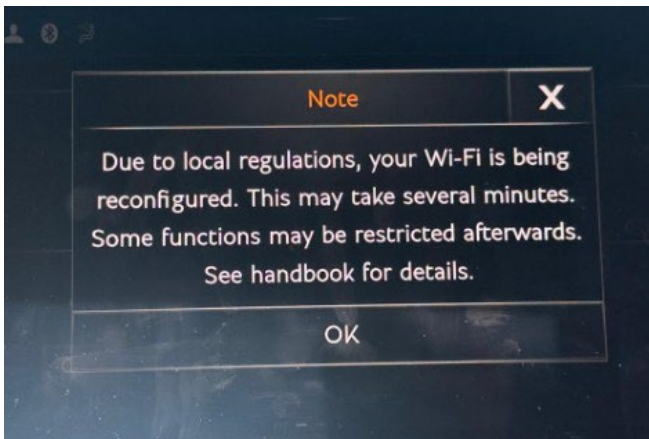
- Apple CarPlay disconnects intermittently during use.
- A WiFi configuration message appears on the MMI screen for approximately 10–15 seconds.
- The message may also be displayed while using native vehicle navigation (not CarPlay).
- Issue may occur in specific geographic locations.

Figure 1. Wi-Fi reconfiguration Notice

No DTCs (fault codes) are stored in any control module related to the infotainment or connectivity systems. Customers may be able to reproduce the concern more easily in certain known locations.

Raise a full DISS query addressed to the Electrical Technical Manager. Attach the following to the DISS ticket:

- Full ODIS diagnostic log
- Video capturing the complaint
- Exact location(s) (GPS coordinates if possible) where the symptom occurs
- Confirm whether the concern is strictly location-specific or occurs in multiple areas.

**As a temporary measure, customers may connect their device using wired CarPlay to avoid disconnections.**
