# M2 with Cummins B6.7 Belt issues

FIELD SOLUTION: *Fix as fail*

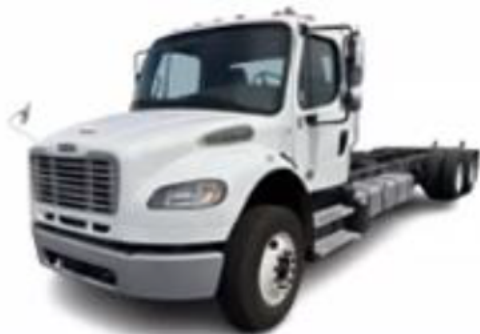
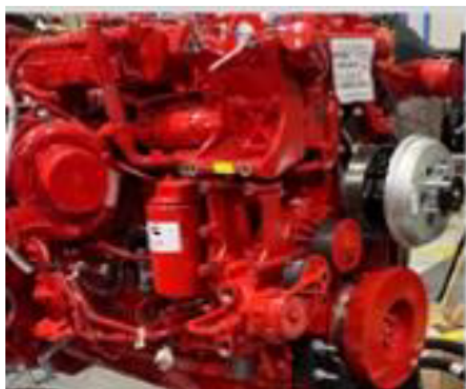
- Dealers & customers have reported some M2's equipped with Cummins 6.7 engines have experienced.
  - Belts slipping, shredding, misalignment or jumping off their pulleys.
  - Through analysis the cause of the issue is due to several part tolerance not being held to a tighter spec.

- Trucks manufactured within suspect date range will be fix as fail.
- For M2's with the B6.7 having belt issues in the field tech's need to refer to.
- The workshop manual & install new belt (01-35643-031) and complete alignment.
- New Cummins platform 7.2 engine production planned for 2027.
