# Side Guard Trailer Detection

## TSB-54-381-FTL

► New Cascadia

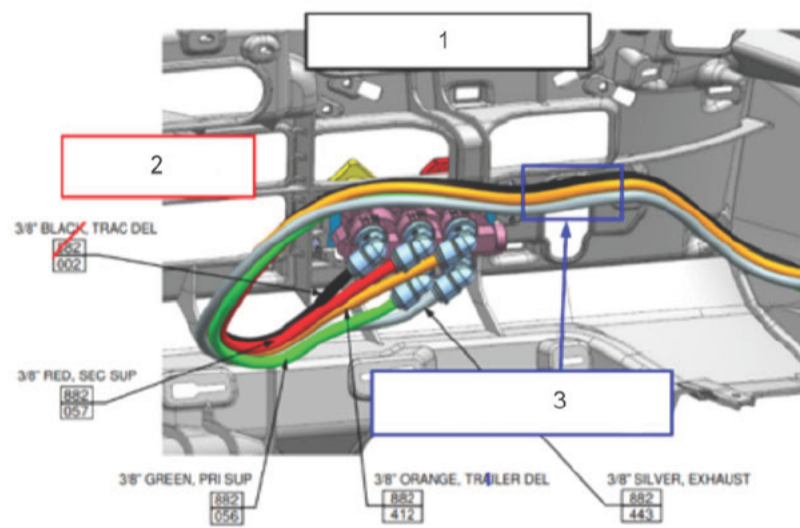
- 1. VM1360 Lead Serial for Werner Fleet
  - 2. Module 882 Missing Pressure Switch
  - 3. Splice in 12-31615-000 and 23-14416-001 Into Orange Line
- Fig. 5, Installation Drawing

4.  Once the dashboard lower panel is removed, locate and splice the air T with a sensor into the orange trailer delivery line. See Fig. 4 and Fig. 5.
