PRODUCT CAMPAIGN BULLETIN

APPLICABILITY: 2020-2022 MY Legacy
2020-2022 MY Outback

NUMBER: WRA-24R

SUBJECT: Safety Recall – ODS Sensor Replacement

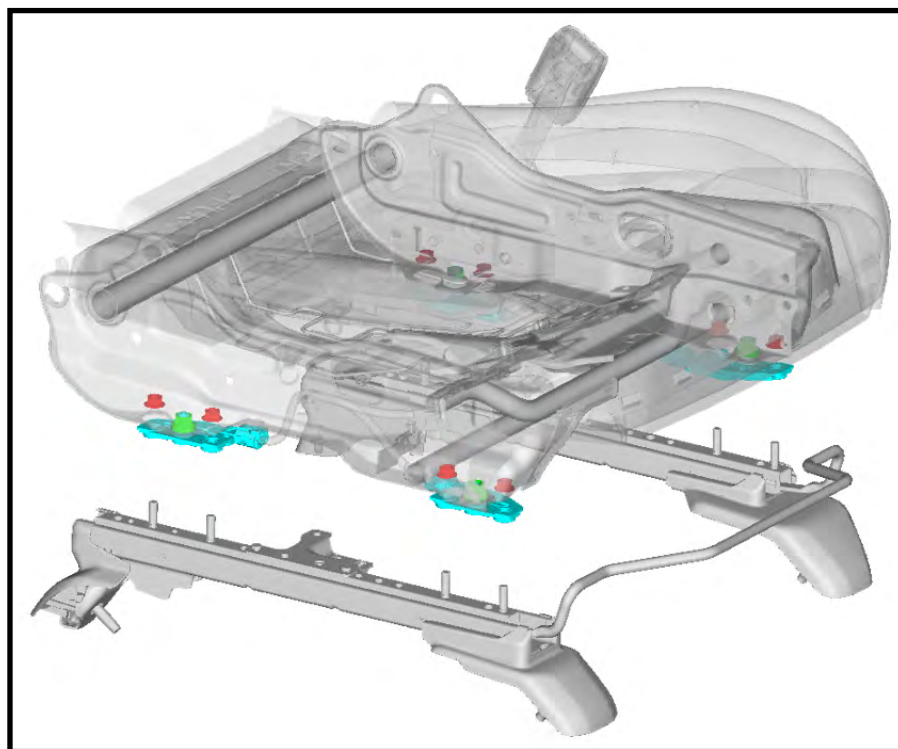
NOTE: In rare instances, the stud attached to the ODS sensor may spin when attempting to remove the nut. If this occurs, remove the 8mm nuts (shown in red in the image below) securing the ODS sensors to the seat frame.

Attach a 19mm twist socket and ratchet to the bottom portion of the stud to prevent it from spinning, then remove the nut securing the ODS sensor to the seat bottom.

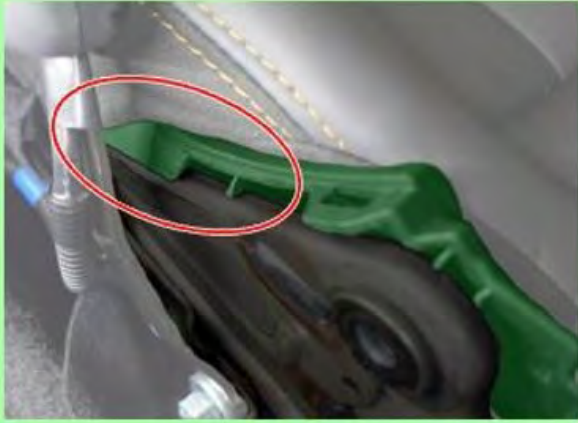
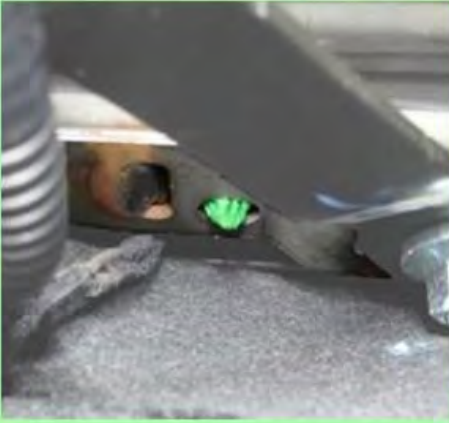
Mounting condition of the cover	Clip Position
✓

STEP 29: Install the inner cushion cover by inserting the grooved section at the tip of the cover along the metal frame. Once in the correct alignment, insert the mounting clip. Confirm the mounting clip positioning when complete.

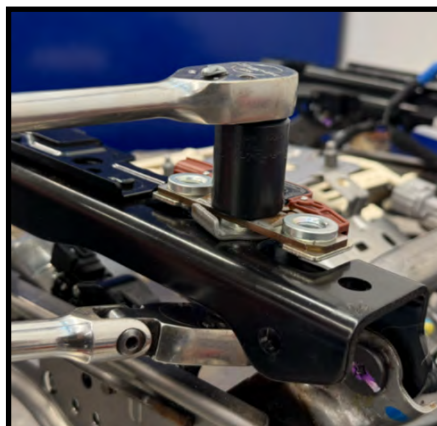
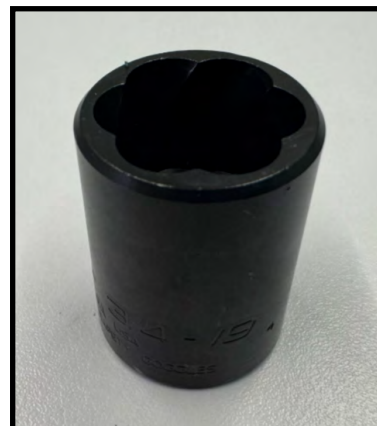
NOTE: In rare instances, the stud attached to the ODS sensor may spin when attempting to remove the nut. If this occurs, remove the 8mm nuts (shown in red in the image below) securing the ODS sensors to the seat frame.

Attach a 19mm twist socket and ratchet to the bottom portion of the stud to prevent it from spinning, then remove the nut securing the ODS sensor to the seat bottom.

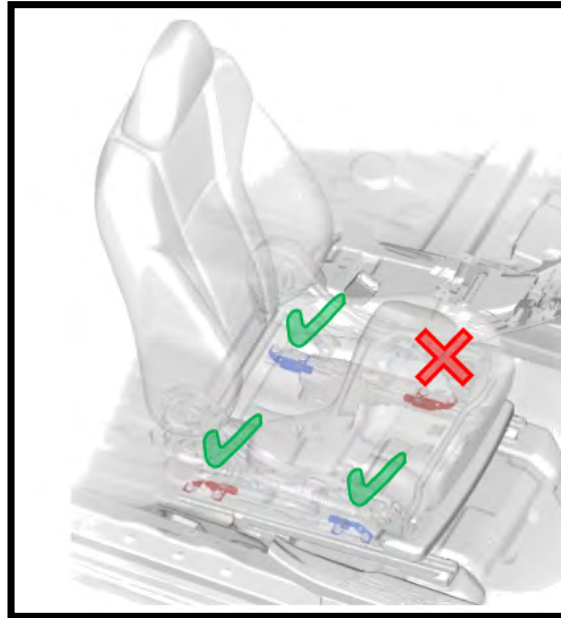
Caution: On power seats, it is not possible to access the back side of the stud on the front inner ODS sensor. If this stud begins to spin, the seat bottom assembly will need to be replaced.
