SERVICE PROGRAM BULLETIN

APPLICABILITY: 2018-19 MY WRX
2018 MY Forester (Turbo)

NUMBER: WRA-26
DATE: 03/16/26

SUBJECT: Rear Catalyst (Center Exhaust Pipe)
Non-Compliance

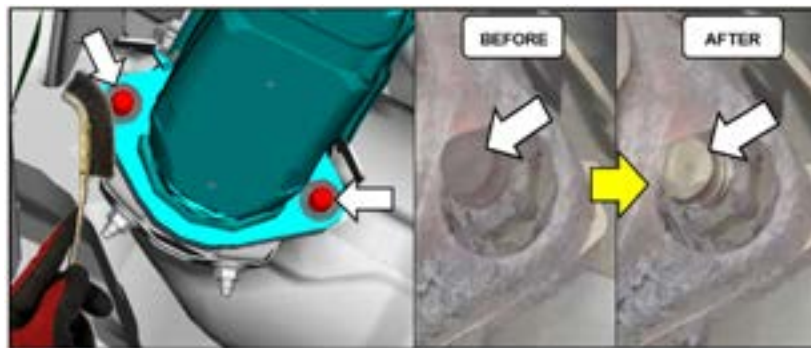
NOTE: The amount of rust may vary depending on the vehicle. The example image below is to be used as reference.

STEP 5: Using a wire brush, remove all rust located on both nuts and studs of the front center exhaust pipe connection.

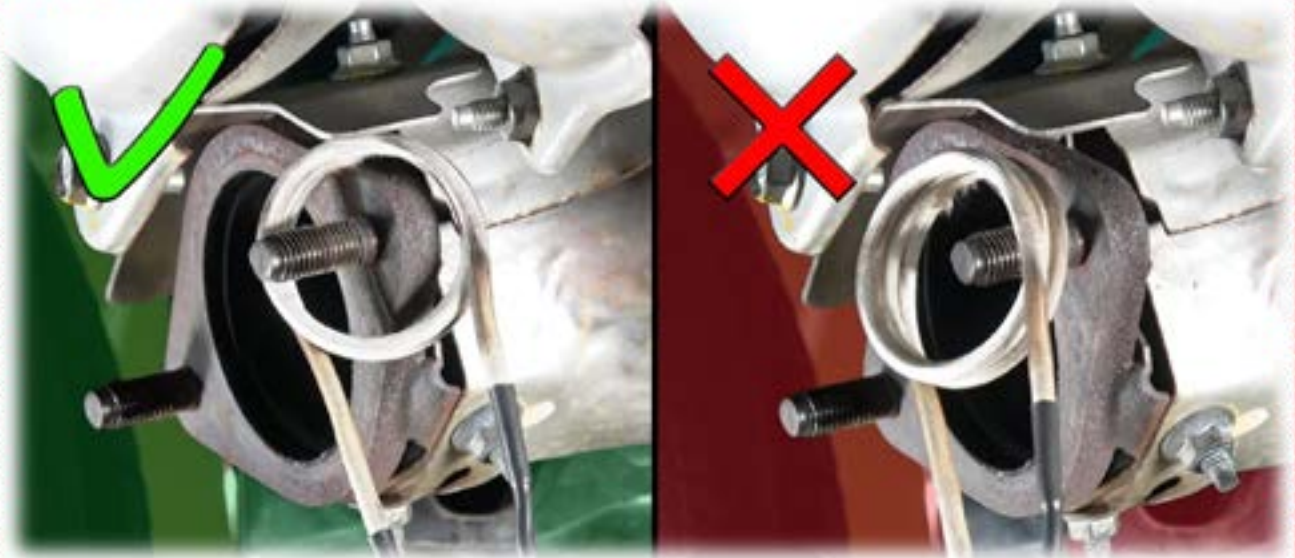
The IH heater coil should be set to heat the base of the stud bolt and the front and back of the flange. If the heating method is incorrect, the target temperature (250° C) will not be reached, and the bolt will not loosen.
