Technical Service Bulletin

**INTERFERENCE BETWEEN FRONT AND REAR DOOR WINDOW
GLASS MOLDING WHEN OPENING/CLOSING FRONT DOOR**

Bulletin No.: 09-012/26

2024 CX-90 (with bright window glass molding) with VINS lower than JM3KK*****113968 (produced before May 16, 2023)

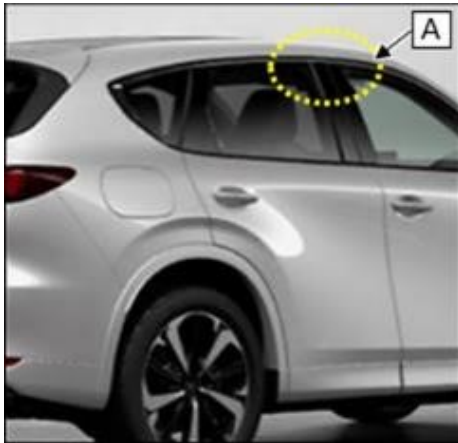
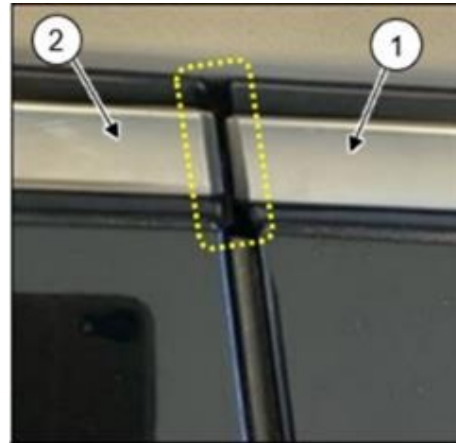
Detail of A

Some vehicles may exhibit an interference between the front (1) and the rear door bright window glass molding (2) due to the bright window glass molding shifting backward when opening/closing the front door.

This is caused by an inappropriate position of the positioning tab on the front door glass run-channel. To eliminate this concern, double-sided tape has been added to the front door glass run-channel, and the shape of the rear end of the front door glass run-channel has been modified to prevent the bright window glass molding from shifting. Customers having this concern should have their vehicle repaired using the following repair procedure.

1. Verify the customer concern.
2. Replace the front glass run-channel(s) with a modified one(s) according to the instructions in MGSS (FRONT DOOR GLASS RUN-CHANNEL REMOVAL/INSTALLATION).
