Technical Service Bulletin

Mazda North American Operations
Irvine, CA 92618-2922

Subject: DOOR OUTER HANDLE TOUCH SENSOR DOES NOT WORK (LOCK AND/OR UNLOCK)	Bulletin No.: 09-013/26
	Last Issued : 03/31/2026

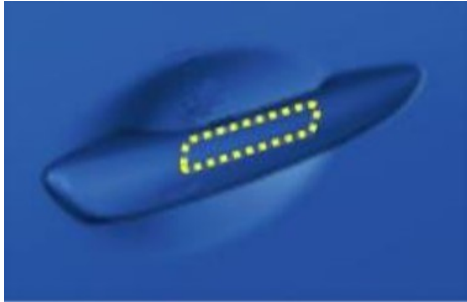
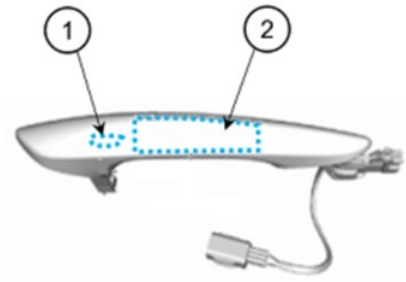
- Symptom 1: The touch sensor of the front door outer handle does not lock the doors after rain and/or car washing, even though unlocking is possible.
- Symptom 2: The touch sensor of the front door outer handle does not unlock the doors.

Door outer handle touch sensor for locking (1) / unlocking (2)

1. [MX-30] After using cabin preconditioning or hazard warning lights for approx. 15 minutes.
 2. [MAZDA3 and CX-30] After using hazard warning lights for approx. 15 minutes.
 3. [MAZDA3, CX-30 and MX-30] When both touch sensors are touched at once.
- Cause 1 (for Symptom 1): Water may accumulate around the touch sensor in the outer handle, resulting in temporary lower sensitivity of the capacitive sensor. Also, if car wash foam gets inside the outer handle while washing the vehicle, the foam may disturb the touch sensor detection. Mazda is still working on a mass production change for this concern.
 - Cause 2 (for Symptom 2): Improper soldering in the production process may disturb the touch sensor detection. To eliminate this concern, the production process has been modified.

1. Verify customer concern.
2. Repair the vehicle depending on the experienced symptom(s).
 - Symptom 1: Follow the "Procedure to waterproof a touch sensor" below to make the touch sensor waterproof.
 - Symptom 2: Replace the front outer handle with a modified one according to the instructions on MGSS.
 - Mazda3 ([FRONT OUTER HANDLE REMOVAL/INSTALLATION](#))
 - CX-30 ([FRONT OUTER HANDLE REMOVAL/INSTALLATION](#))
 - MX-30 ([FRONT OUTER HANDLE REMOVAL/INSTALLATION](#))
 - If both symptoms are experienced: Replace the front outer handle with a modified one and follow the "Procedure to waterproof a touch sensor" below to make the touch sensor waterproof.
