**Location:** Electrical

**Topic:** ADI slow to respond

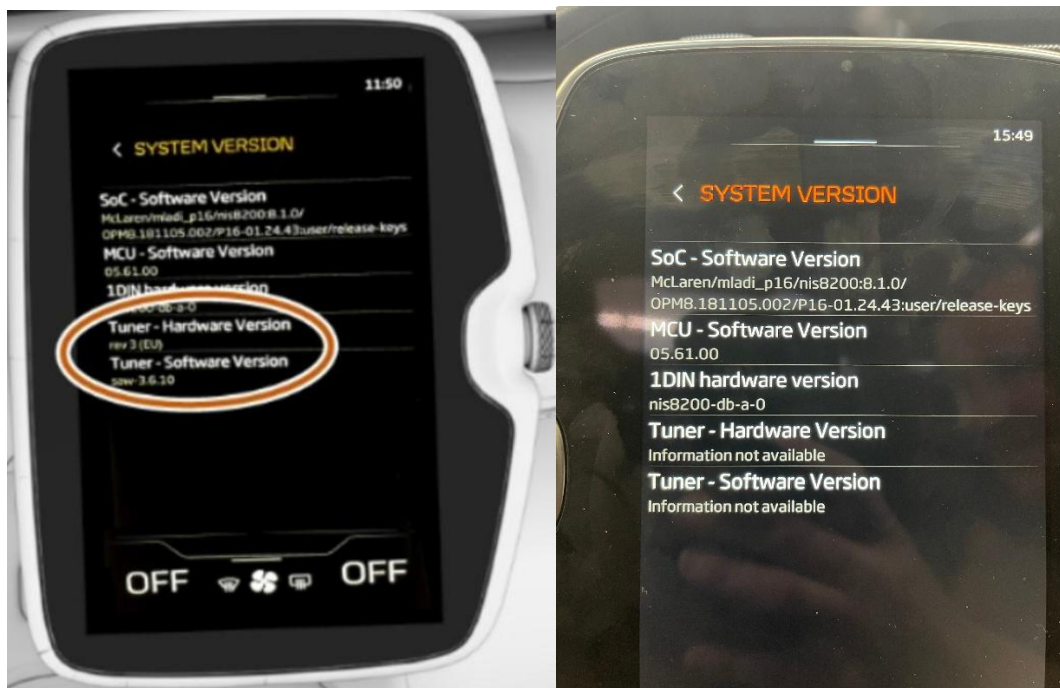
- If possible please check the "System Version" page in the ADI. Check to see if the tuner software version is displayed

The images below shows the ADI "System Version" with and without the software number displayed.

If either of the above checks do not show the tuner part number then the smart tuner must be inspected.

- Check that the tuner is correctly fitted and that all plug connections are fully connected
- Check the wiring to the tuner for any damage, backed out pins and check pin drag
- Check for any aftermarket devices wired into the tuner harness

If no physical faults are found with the tuner or its wiring please refer to **KA-01896**
