**Topic:** Vehicle not charging warning diagnosis steps

**Diagnostic Trouble Codes:** P0D6700 - EDS-Battery Charger Control Module Performance - No Sub Type Information

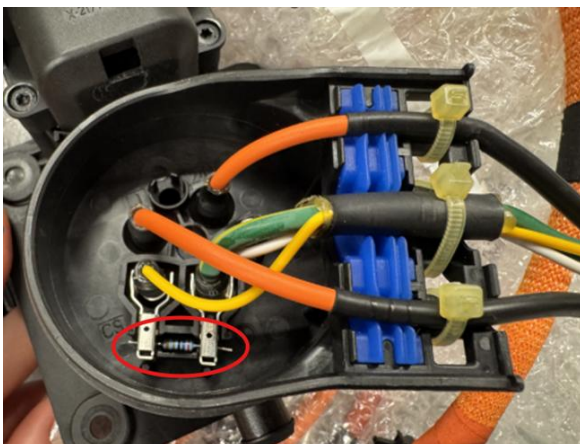
- Check the integrity of the resistor located at the back of the Type 1 Charge Port. Measure the resistance of the resistor in place. This reading should be approximately 2.7k $\Omega$

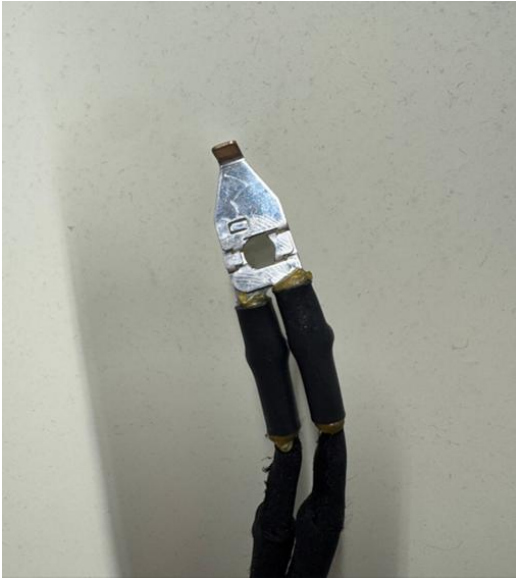
- Check the integrity of the ground located on the left of the rear frame. Ensure the grounds are correctly interlocked with each other, secure and clean

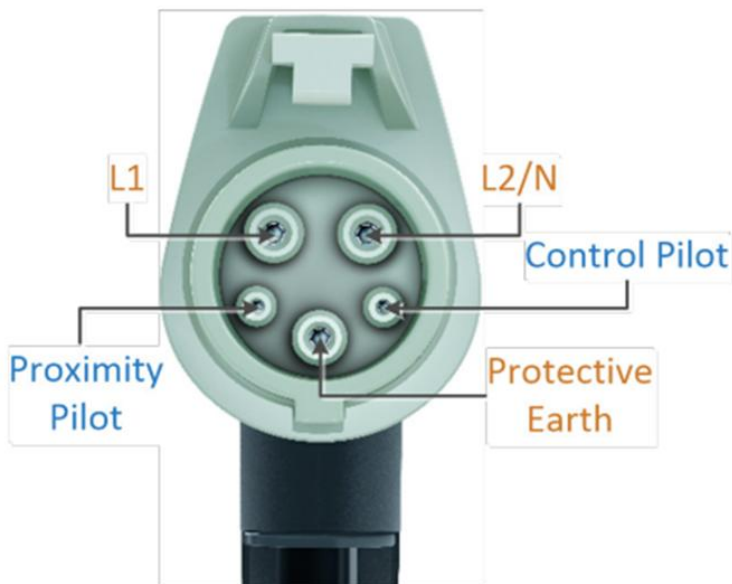
- Measure the resistance of the wiring for the proximity and control pilot lines from the charge port to the intermediate connector located in the wheel arch. Ensure there is no water ingress, backed out pins or corrosion to this connector

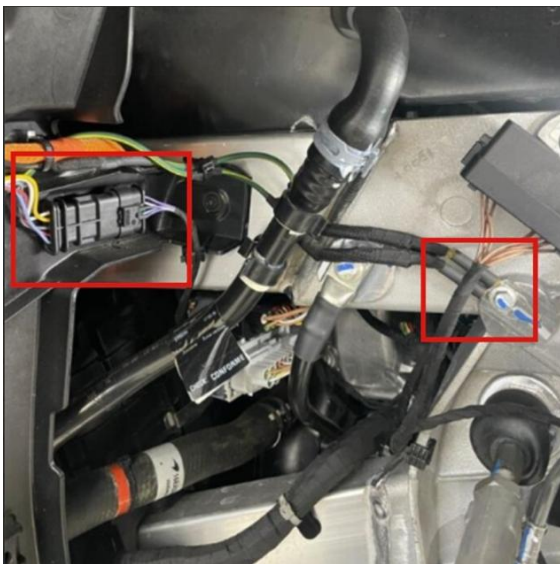
### Type 2 Charge Port

- Measure the resistance for the protective earth at the front of the charge port connector to the rear frame earth

**Care Point:** The wiring diagram lists the control pilot as being violet, however it is yellow.

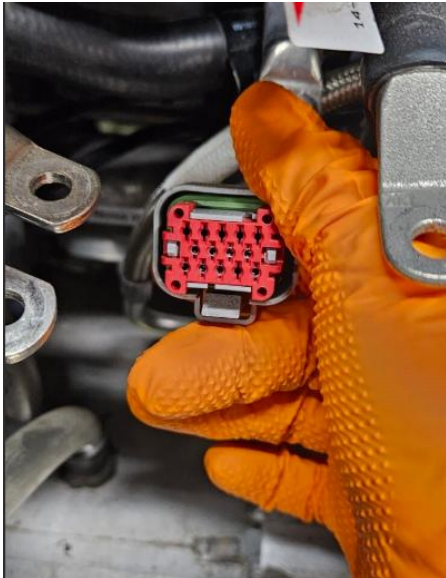
- Measure the resistance for the control and proximity pilots from the intermediate connector to the IPU. Ensure there is no water ingress, backed out pins or corrosion to this connector

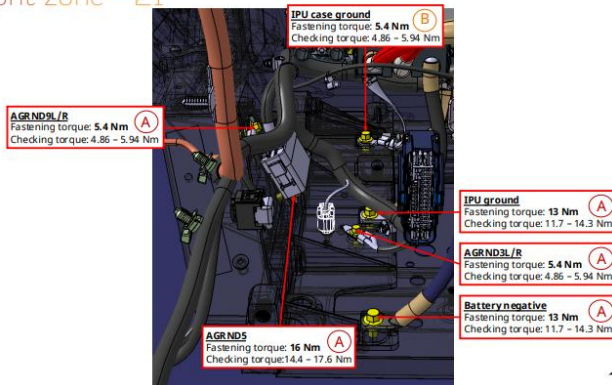
Front zone – Z1

- Inspect the power and ground cables for the IPU located on the front subframe
