# 26-001 DDC DT12 Range Detent Diagnostic

Some DT12 shifting complaints may be corrected by installing the updated Range Detents.

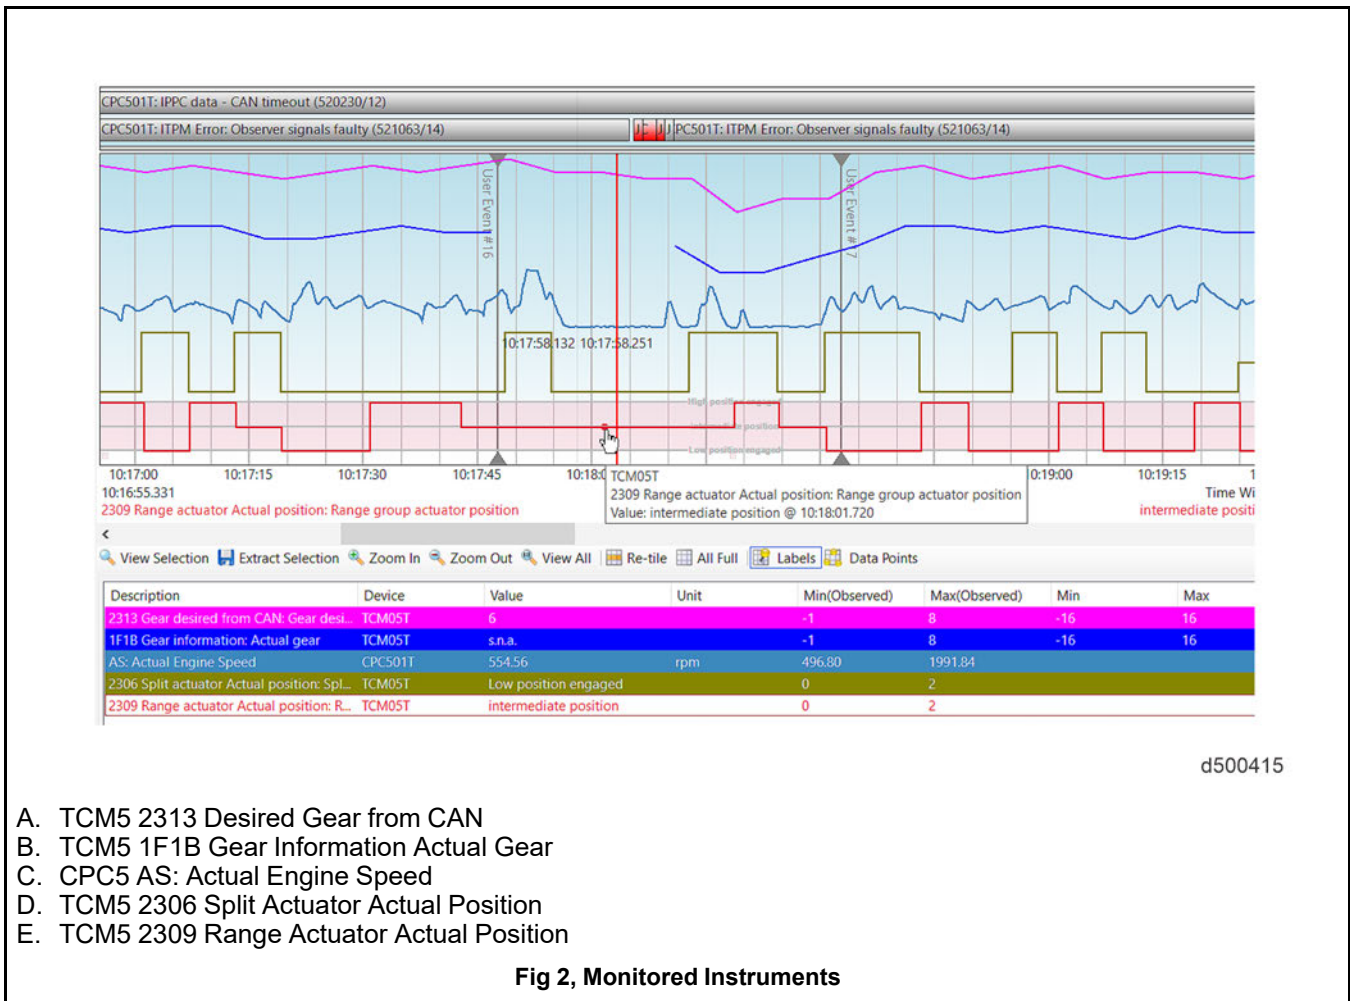
Fig 1, Range Reversing Events

2. Navigate to the 'Identification' screen, under 'Stored Data'. Look in 'TCM 22-22-21' for reversing events (events counter is usually greater than 30 and as high as 700). See 1, [Range Reversing Events](#), and chart the log file to identify range 'hang-up/intermediate' position. See 2, [Monitored Instruments](#). Does the events counter read 0 or does the chart show the range in an intermediate position?

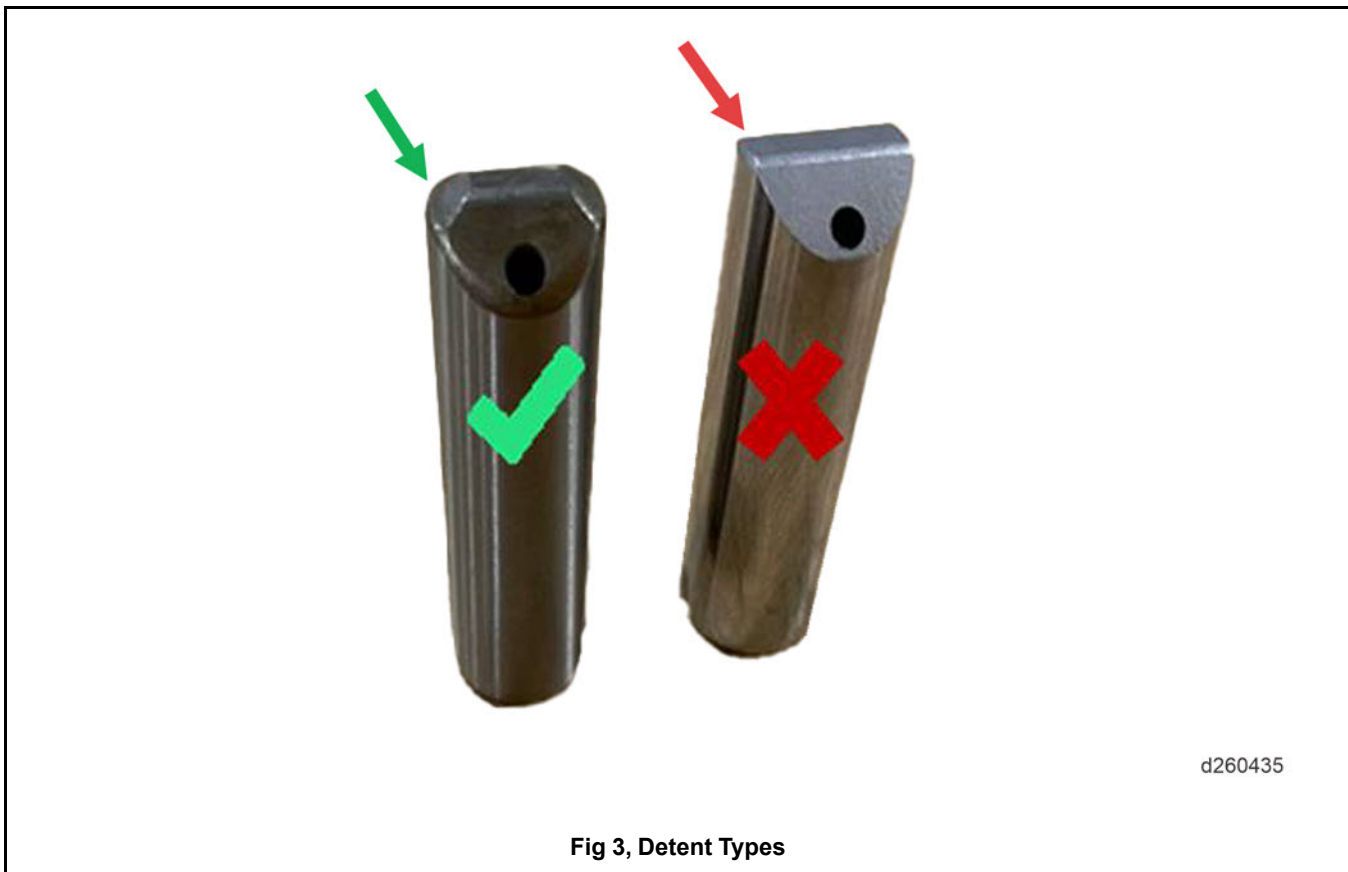
- 2.a Yes; see [Range Up or Down Shift Issue](#) and continue trouble shooting.
- 2.b No; go to step 3..
- 3. Remove and inspect the detents. See [Removal of the Range Detent](#). Is the detent type with the red X installed (see below image)?

- 3.a Yes; replace both detents and go to step 4..
- 3.b No; reinstall the equipped detents and go to step 4.. See [Installation of the Range Detent](#).
- 4. Remove the range piston cylinder. see [Removal of the Range Cylinder](#).
- 5. After removing the range piston cylinder, actuate the range piston by repeatedly pulling and pushing on the piston (by hand) to confirm that the detents are seated on the rod. The rod should not move freely or easily when pulling and pushing the range piston by hand. Does the range piston rod move freely?
  - 5.a Yes; replace the transmission. See [Removal of the Transmission](#).
  - 5.b No; see [Range Up or Down Shift Issue](#) to continue trouble shooting.
