Subject: REPLACEMENT OF WATER PUMP FOR COOLANT LEAK	Service Alert No.: SA-014/26
	Last Issued : 03/11/2026

APPLICABLE MODEL(S)/VINS

2018-2026 Mazda3	2018-2026 CX-5	2020-2026 CX-30	2025-2026 CX-70 (All)
2018-2021 Mazda6	2018-2023 CX-9	2023-2026 CX-50 (All)	
2018-2021 CX-3	2018-2024 MX-5	2024-2026 CX-90 (All)

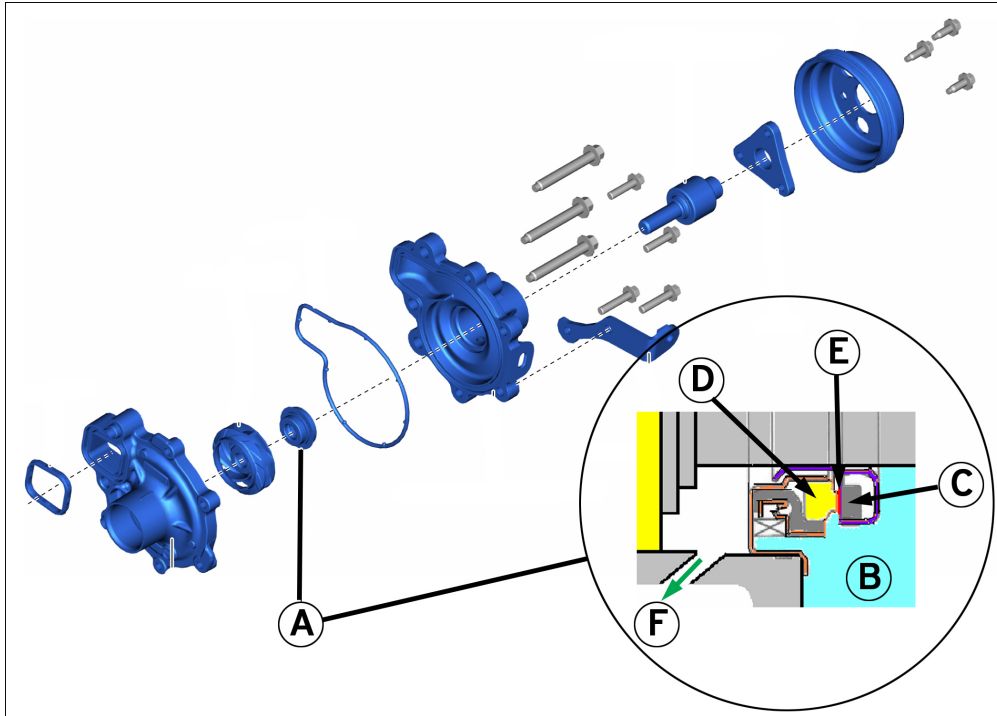
A mechanical seal (A) is used for the water pump. This mechanical seal can seal coolant (B) by sliding a mating ring (C) against a seal ring (D). When the sliding surface temperature of the mechanical seal is more than 248 °F (120 °C) while driving, a small amount of steam (E) is leaked and bleeds through the bleeding hole (F). After drying, the steam leaves a green coolant deposit near the water pump bleed hole (F). This is a normal condition and does not require water pump replacement. The water pump should only be replaced if there is an accumulation of crystallized coolant near the bleed hole.

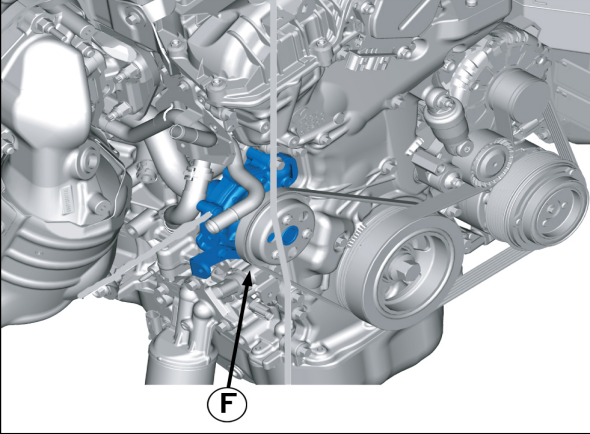
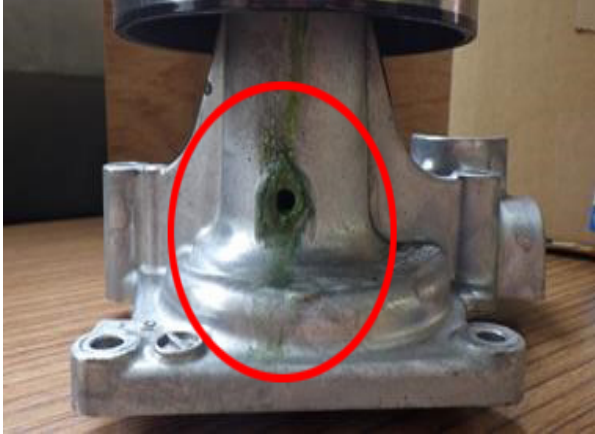
<p>Bleed hole (F) is located under water pump</p>	<p>Dried coolant steam shows as green-color deposit at bleed hole</p>

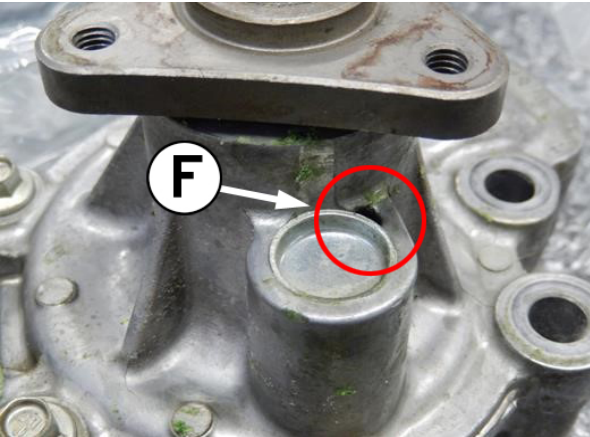
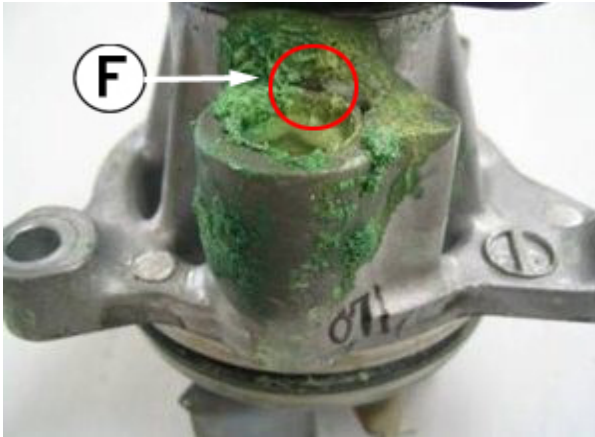
<p>Water Pump Samples:</p>	
<p>GOOD No accumulation of crystallized coolant near the bleed hole (F). DO NOT replace the water pump.</p>	<p>NO GOOD Accumulation of crystallized coolant near the bleed hole (F). REPLACE the water pump.</p>

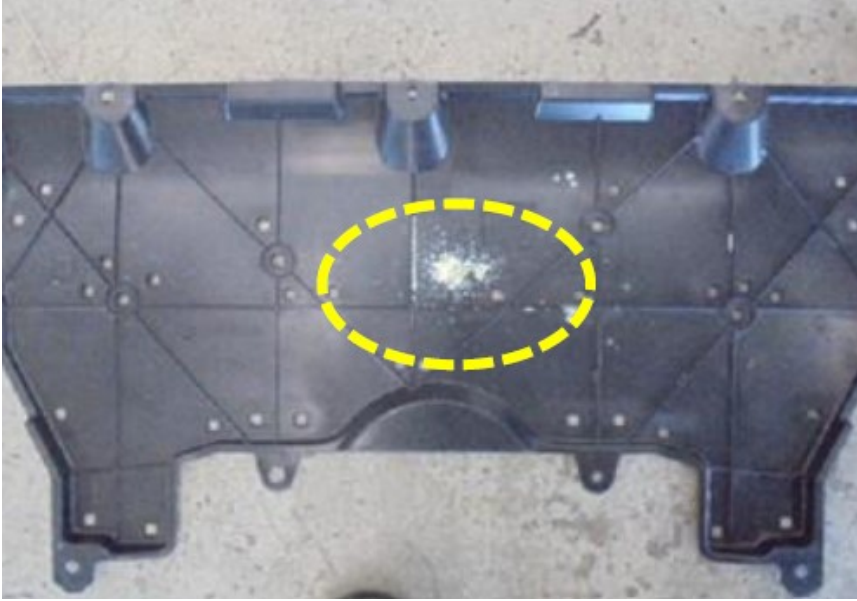
Mileage under 1,860 miles (3,000 km):

- If the leakage amount is at the level shown in the figure below, replacement is not necessary.

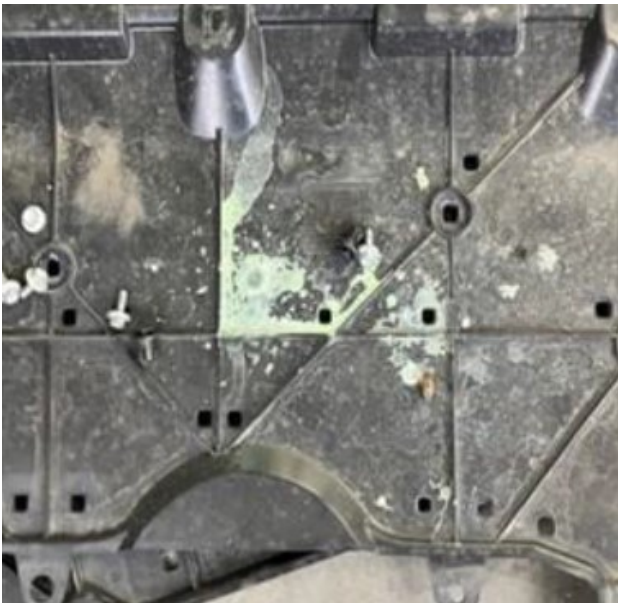
Mileage over 1,860 miles (3,000 km):

- If the leakage amount is at the level shown in the figure below and the coolant is dry, replacement of the water pump is not necessary. Sample at 31,070 miles (50,000 km).

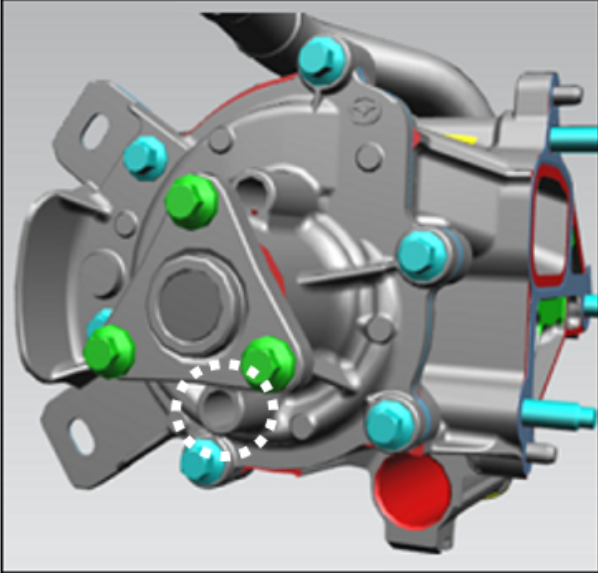
**SKYACTIV-G 2.5 (PYUL)**

- Regarding the following engines, diagnose whether the water pump requires replacement as with the other engines in this service information.
- Refer to the following images regarding the location of the bleeding hole (white dotted circle).
