<b>Subject:</b>  <b>GLOBE WITH SLASH ICON AND SOMETIMES BEEP SOUND NEAR SOS BUTTON</b>	<b>Service Alert No.: SA-015/26</b>
	<b>Last Issued : 03/13/2026</b>

2026 CX-5 (KM)

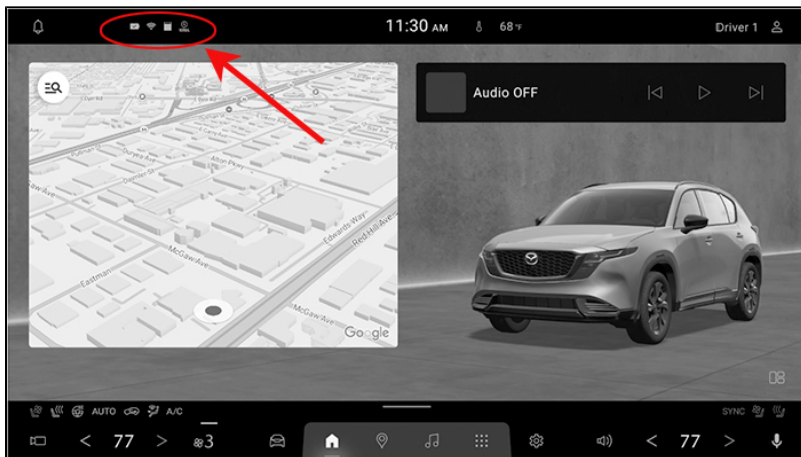
1. Intermittent Globe with a slash icon.

- The Globe with Slash icon indicates that communication between the Cockpit Domain Controller (CDC) and the Data Communication Module (DCM) has not yet been completed.
  - This communication may take up to 90 seconds to complete. During this time, some Mazda Connect 3 functions, such as Google Assistant, will not be available.
  - Once communication is complete, the Globe with Slash icon will be replaced by the reception icon, as shown below.

- If communication between the CDC and DCM does not complete within 90 seconds, the system has experienced an interruption. Advise the customer that Mazda is aware of the condition and is currently working on a resolution. As soon as a resolution becomes available, this Service Alert will be promptly updated and re-released.
  - **NOTE:** Vehicle driving operation is not affected during this condition.

- After several minutes of driving.
- Ignition OFF and wait approximately 5 minutes. Then ignition back ON.

1. Disconnect the 12V battery.
2. Wait about 1 minute.
3. Reconnect the 12V battery and retest.

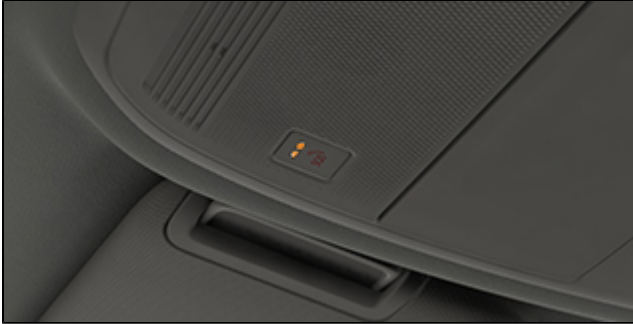
2. Beep sound near the SOS button and SOS button amber LED.

- This condition is related to Item 1 above. Advise the customer that Mazda is aware of the condition and is currently working on a resolution. As soon as a resolution becomes available, this Service Alert will be promptly updated and re-released.

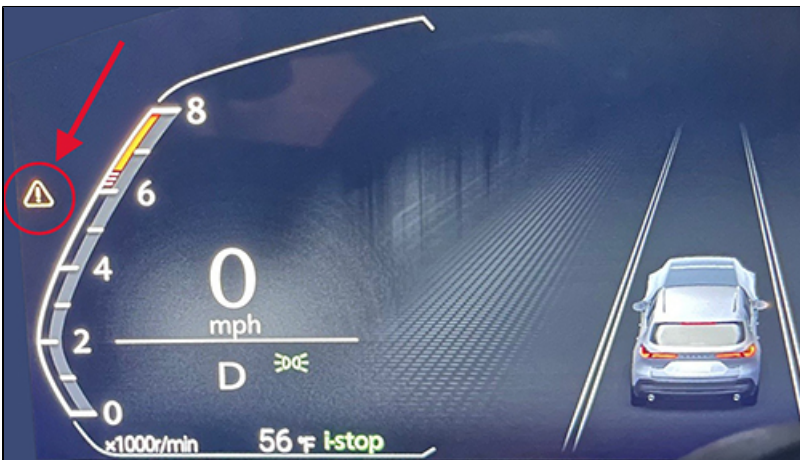
3. Instrument Cluster Master Warning Light may be illuminated.

- Emergency Call Unit Malfunction Notification
  - Center Display Home screen --> All Apps --> Efficiency --> Notifications
- This condition is related to Item 1 above. Advise the customer that Mazda is aware of the condition and is currently working on a resolution. As soon as a resolution becomes available, this Service Alert will be promptly
