# Service Alert

<b>Subject:</b>  INFOTAINMENT CENTER DISPLAY AND CONNECTED VEHICLE IMPROPER OPERATION	<b>Service Alert No.:</b> SA-015/26
	<b>Last Issued :</b> 03/25/2026

2026 CX-5 (KM)

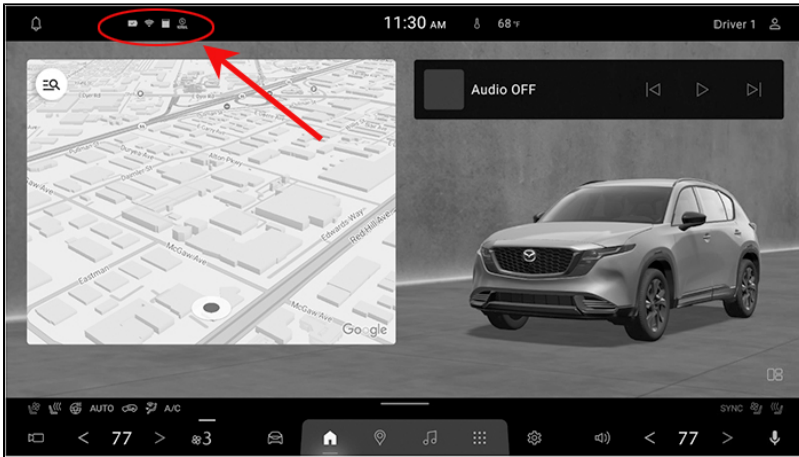
1. Intermittent Globe with a slash icon

- The Globe with Slash icon indicates that communication between the Cockpit Domain Controller (CDC) and the Data Communication Module (DCM) has not yet been completed.
  - This communication may take up to 90 seconds to complete. During this time, some Mazda Connect 3 functions, such as Google Assistant, will not be available.
  - Once communication is complete, the Globe with Slash icon will be replaced by the reception icon, as shown below.

- If communication between the CDC and DCM does not complete within 90 seconds, the system has experienced an interruption. Advise the customer that Mazda is aware of the condition and is currently working on a resolution. As soon as a resolution becomes available, this Service Alert will be promptly updated and re-released.
  - **NOTE:** Vehicle driving operation is not affected during this condition.

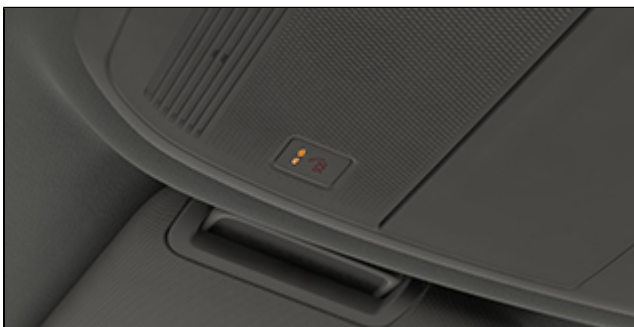
## 2. Beep sound near the SOS button and SOS button amber or red LED

- This condition is related to Item 1 above. Advise the customer that Mazda is aware of the condition and is currently working on a resolution. As soon as a resolution becomes available, this Service Alert will be promptly updated and re-released.

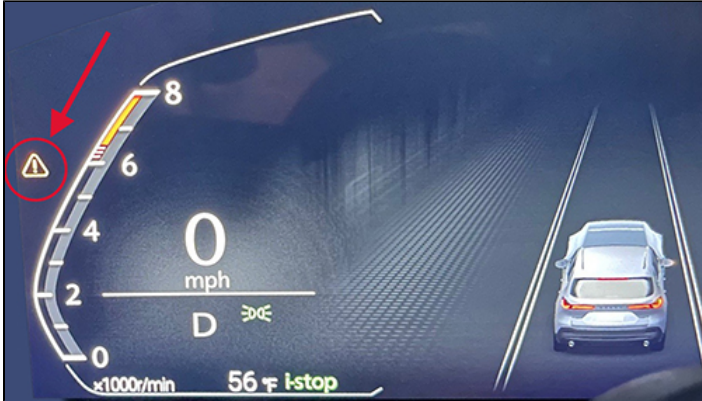
### 3. Instrument Cluster Master Warning Light may be illuminated

- Emergency Call Unit Malfunction Notification
  - Center Display Home screen --> All Apps --> Maintenance --> Notifications
- This condition is related to Item 1 above. Advise the customer that Mazda is aware of the condition and is currently working on a resolution. As soon as a resolution becomes available, this Service Alert will be promptly updated and re-released.

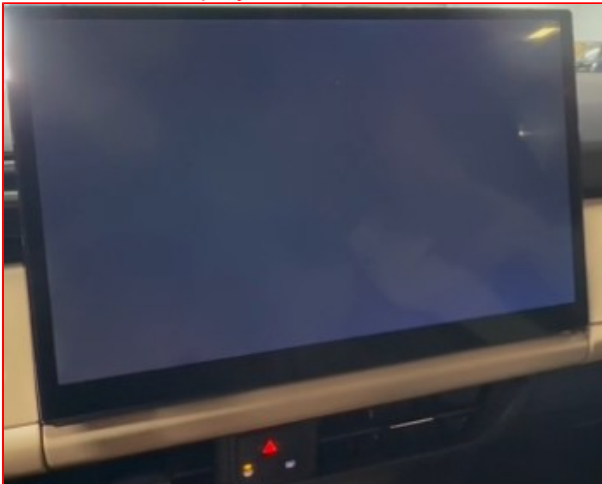
### 4. The center display screen is blank

- This condition is related to Item 1 above. Advise the customer that Mazda is aware of the condition and is currently working on a resolution. As soon as a resolution becomes available, this Service Alert will be promptly updated and re-released.

**NOTE:** The rear view camera display while in "Reverse" remains operational during this condition.

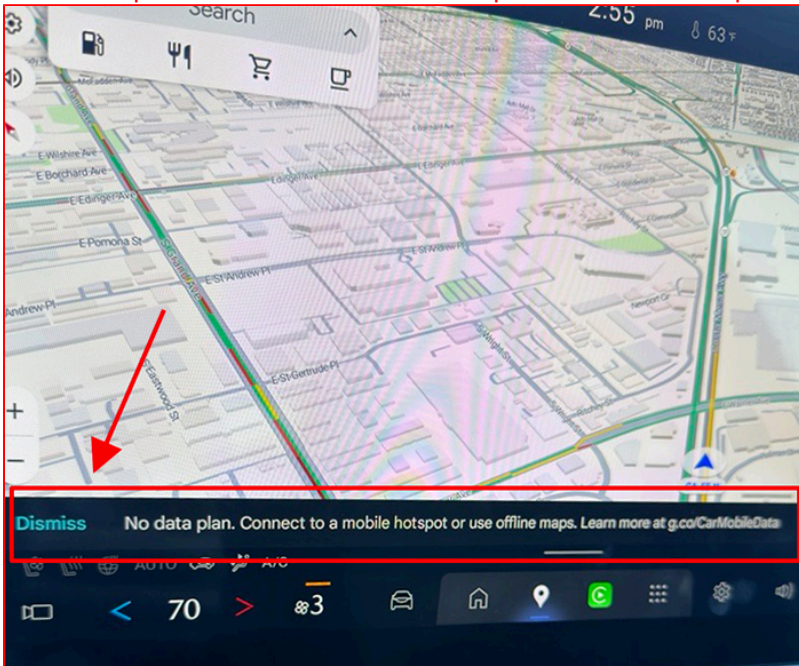
5. No data plan. Connect to a mobile hotspot or use offline maps. learn more at [g.co/CarMobileData](https://g.co/CarMobileData) message

- This message is incorrect.
- It does not affect system operation.
- Dismissing the message may temporarily clear it.
- Please ignore this message at this time.
- This condition is related to Item 1 above. Advise the customer that Mazda is aware of the condition and is currently working on a resolution. As soon as a resolution becomes available, this Service Alert will be promptly updated and re-released.
