Subject: HANDS-FREE LIFTGATE POOR PERFORMANCE AFTER TRAILER HITCH INSTALLATION	Service Alert No.: SA-020/26
	Last Issued : 03/26/2026

2024-2026 CX-90 equipped with hands-free liftgate function and Mazda genuine trailer tow hitch
 2025-2026 CX-70 equipped with hands-free liftgate function and Mazda genuine trailer tow hitch

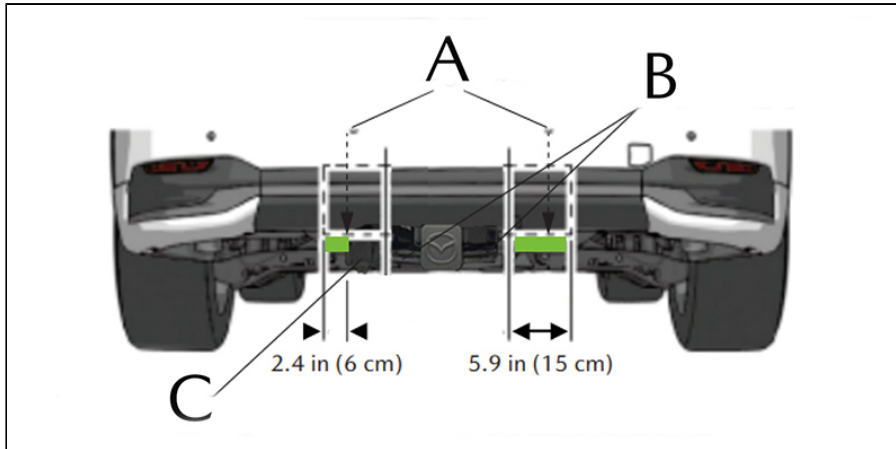
**Foot Sensing Area
Equipped with Mazda genuine trailer tow hitch**

Sensing areas are outside of the chain plates (B) and 7-pin socket (C), and approximately below the parking sensors (A) (if equipped).

A. Parking Sensor (if equipped)
B. Chain Plate
C. 7-Pin Socket

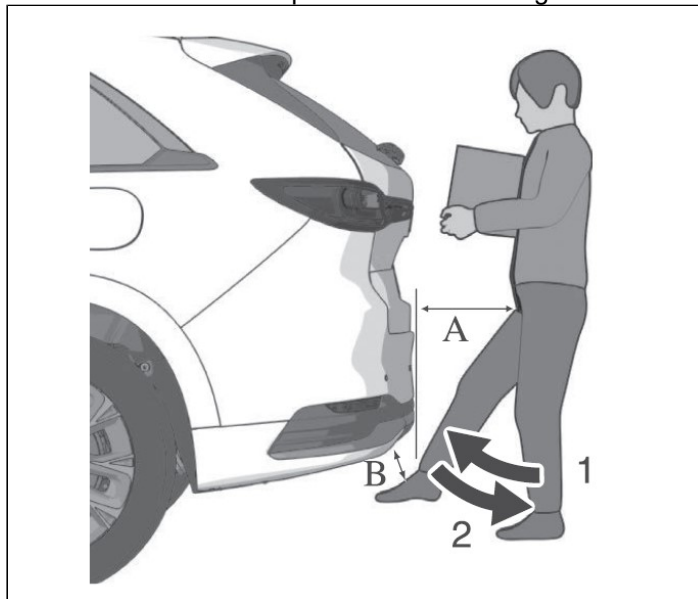
Quick KICK* within 1 second.

About 3/4 in (2 cm) or less from the bottom of the bumper within the sensing areas.

A : About 30-50 cm (12-19.7 in)
B : About 20 cm (3/4 in) or less

* DO NOT swing or swipe.

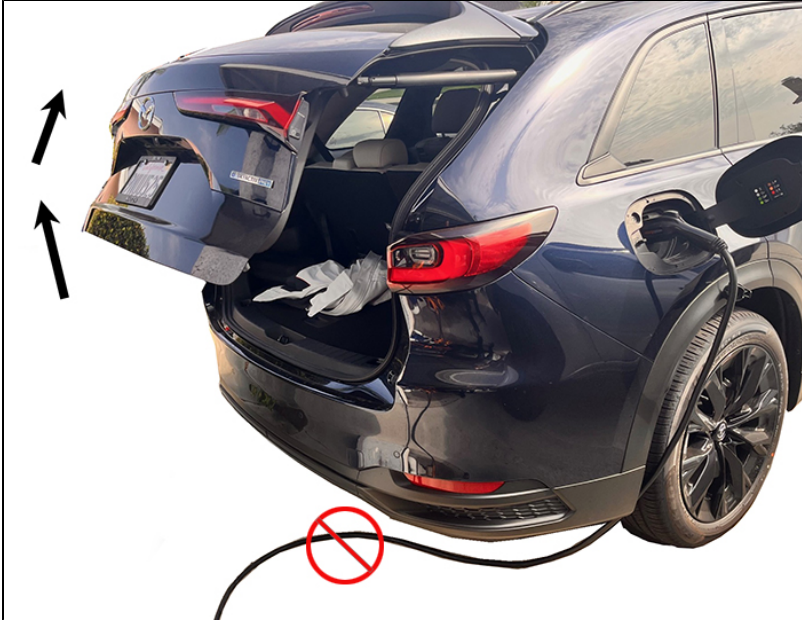
The PLG Hands-free sensor may detect the movement of the charging cord when charging, causing the liftgate to open unintentionally and a risk of liftgate damage.

NOTE: This is a normal operation of the PLG sensor, not a system malfunction

CAUTION (PHEV Model Charging): DO NOT place the charging cord at the bottom of the rear of the vehicle and DO NOT let the cable hang around at the rear of the vehicle.
