## Technical product information

<b>Topic</b>	Water Ingress - Rear Quarter Area and Rear Passenger Footwell   Continental GT
<b>Market area</b>	Bentley: worldwide (2WBE),China 796 VW Import Comp. Ltd (Vico), Beijing (6796)
<b>Brand</b>	Bentley
<b>Transaction No.</b>	2081117/1
<b>Level</b>	EH
<b>Status</b>	Released for publishing
<b>Release date</b>	March 6 2026

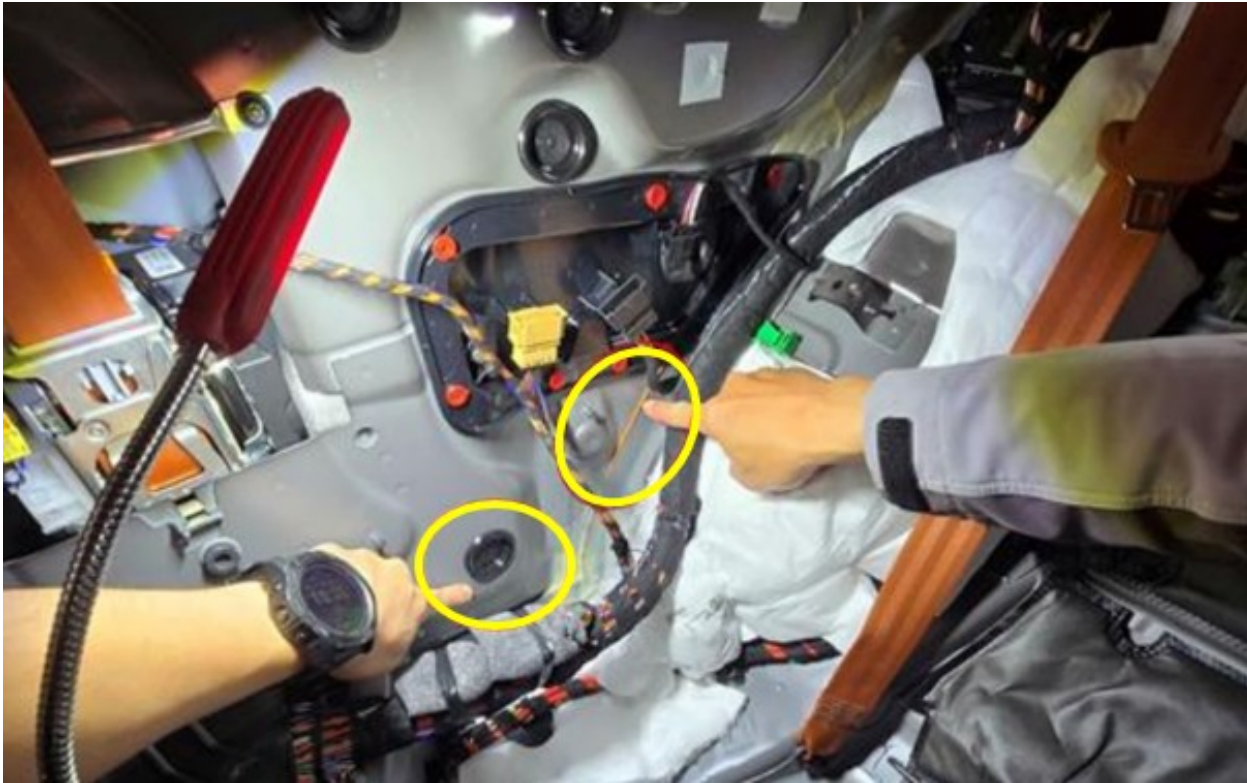
5. Identify water tracing patterns coming through the sealing elements of the water shedder and grommets in the local area shown below.

**Figure 1.** *Location of potential leakage*

6. Confirm shedder sealing fault (gaps, misalignment, crushed foam, adhesive interference).

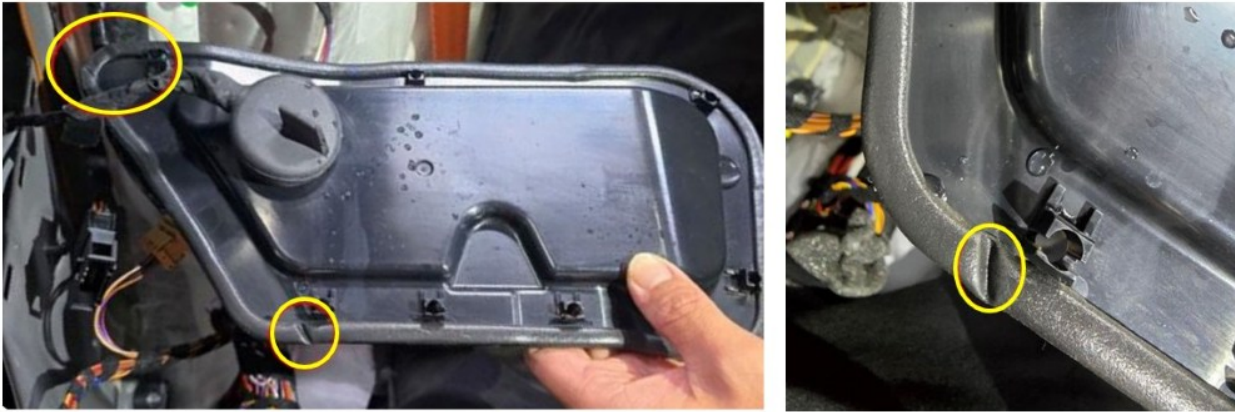
9. Inspect the water shedder deflector butyl seal for any signs of deformation or structural adhesive disruption, as illustrated in the visual below.

**Figure 2.** *Water shedder with signs of deformation*

10. If any damage is identified, replace the water shedder and refer to Step 11 for the procedure to remove the structural adhesive.

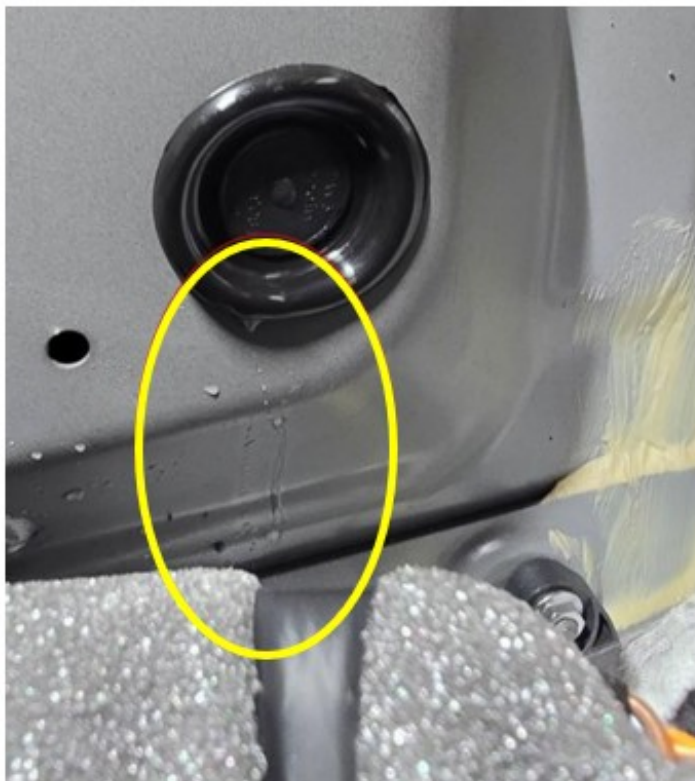
**Figure 3.** *Sealing grommet with signs of leakage*

11. If local grommets shown show signs of leakage, replace the grommets.

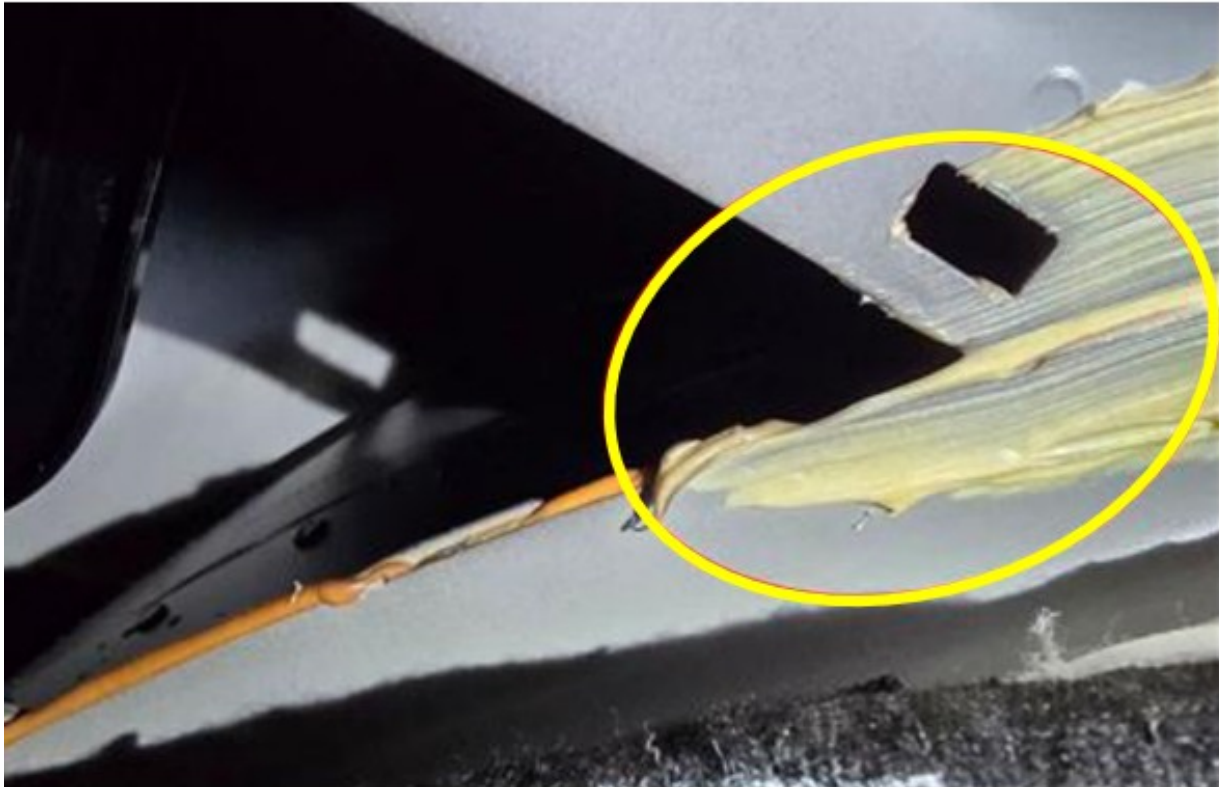
Figure 4. *Excess structural adhesive*

12. Carefully remove excess **ONLY** structural adhesive in local area where there is deformation of the butyl strip on the shedder as shown as in the visual below.

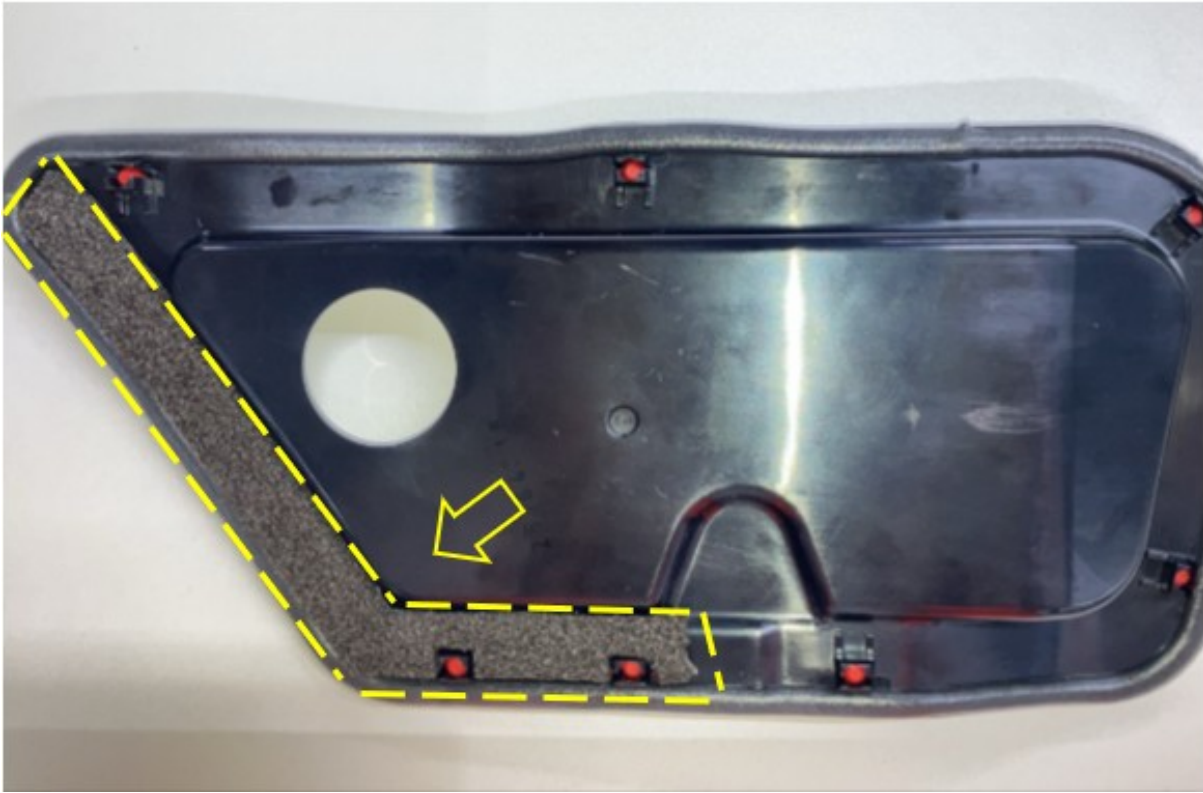
**Figure 5.** Required Nitto foam placement location

13. Clean the mounting surface on the water shedder / deflector as shown below. ("B surface").

14. Apply Nitto foam tape exactly in the illustrated position in figure 5.

- Butt against the butyl seal
- Not overlap butyl
- Not cover clip points

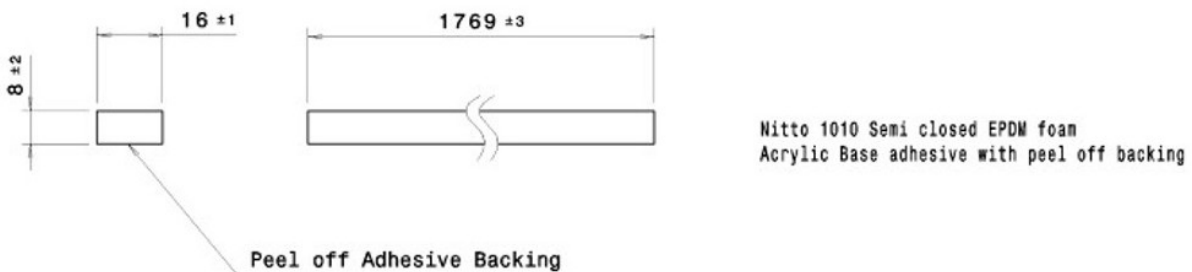
**Figure 6.** Required Nitto foam tape dimensions (mm)

Verify even surface contact along the entire length. See Figure 6 for required tape dimensions (mm).

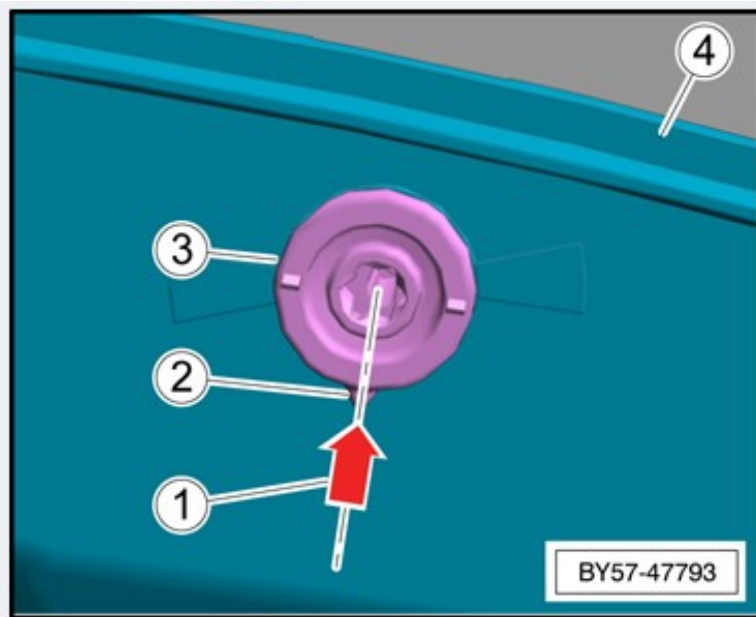
**Figure 7.** *Water shedder/deflector fixings*

Ensure the inner closing panel clips into locating holes and sits flush with the panel before securing the fixings -3- .

- Locate the inner closing panel -4- in position and partially press in the fixings -3- .
- Rotate the fixings 90° clockwise ensuring that the lug -2- aligns with the arrow -1- .
