## Technical product information

<b>Topic</b>	Loss of Cabin Heat During Engine Operation   Bentayga - V8
<b>Market area</b>	Bentley: worldwide (2WBE),China 796 VW Import Comp. Ltd (Vico), Beijing (6796)
<b>Brand</b>	Bentley
<b>Transaction No.</b>	2081236/1
<b>Level</b>	EH
<b>Status</b>	Released for publishing
<b>Release date</b>	March 17 2026

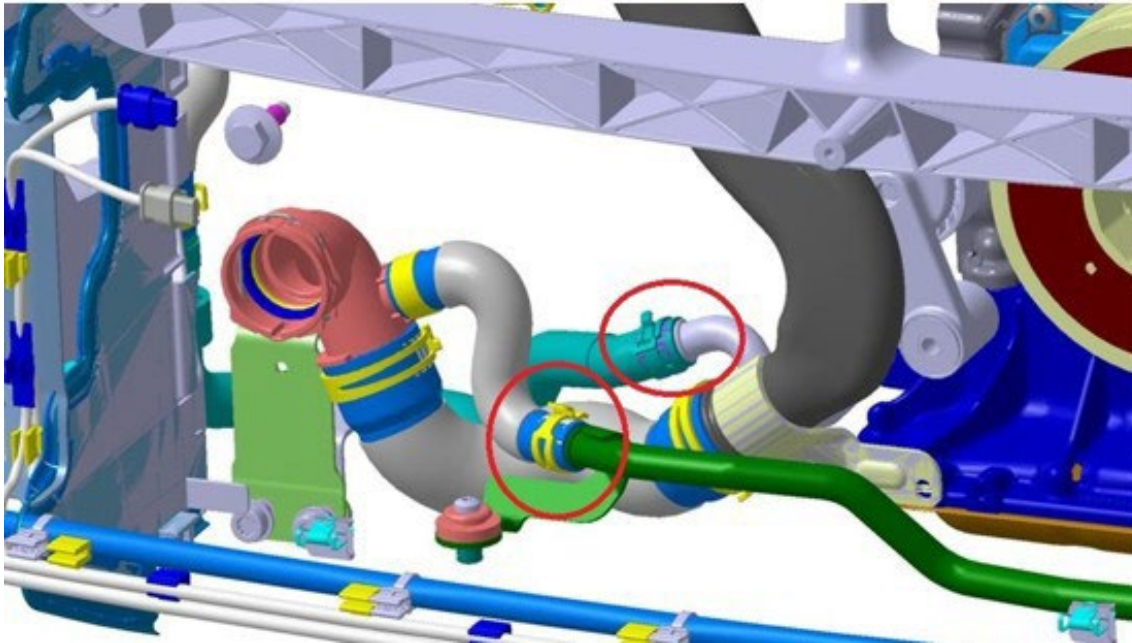
**Figure 1.** Coolant hose inspection (correct orientation)

3. Inspect the two-coolant hose -circled-.

6. Reconnect hoses in their correct positions as shown in figure 1 & 2.

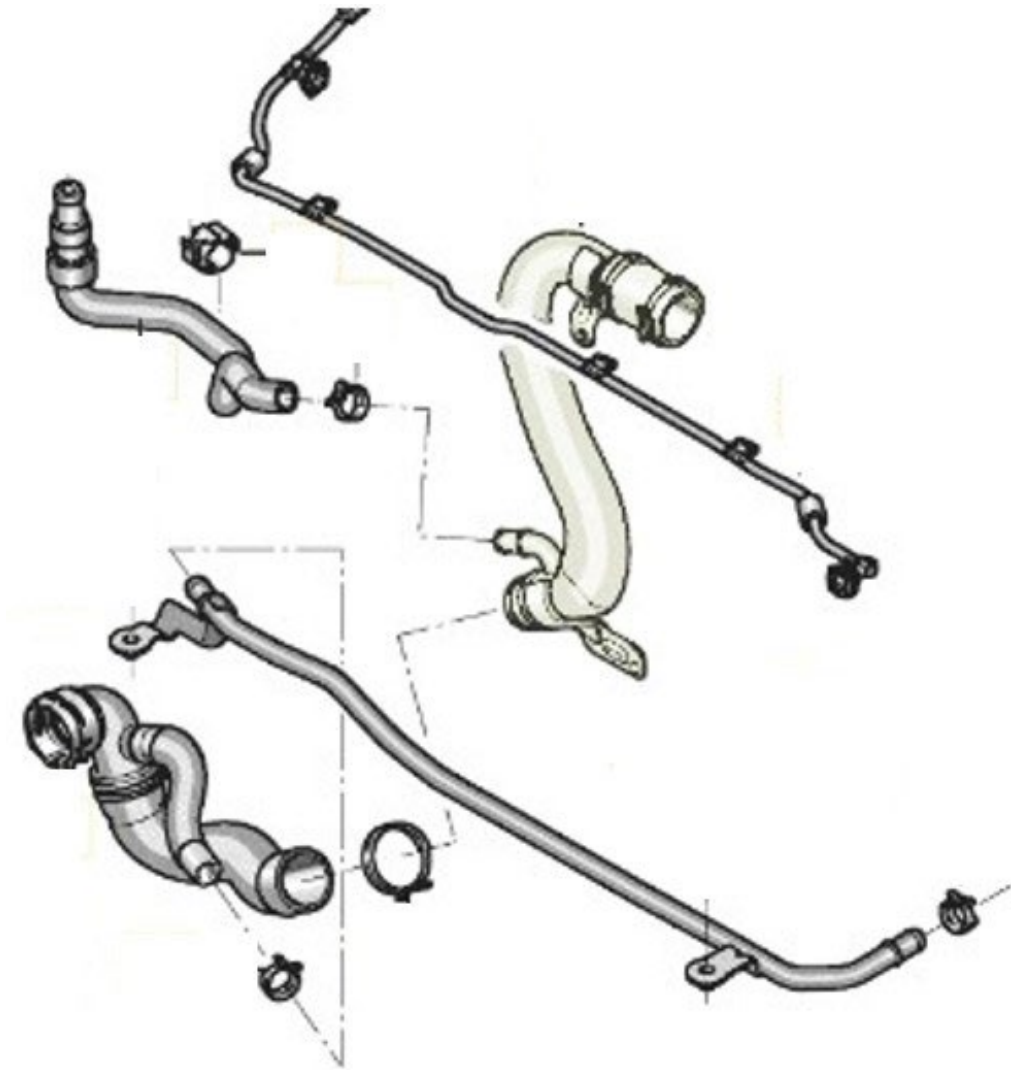
4. Use the diagram below to assist confirming correct hose fitment.

**Figure 2.** Correct coolant hose routing diagram
