Technical product information

Topic	ODIS Error Message – Best Practice When Performing Baseline (BiL) Updates
Market area	Bentley: worldwide (2WBE),China 796 VW Import Comp. Ltd (Vico), Beijing (6796)
Brand	Bentley
Transaction No.	2078962/4
Level	EH
Status	Released for publishing
Release date	March 17 2026

ODIS Error Message – Best Practice When Performing Baseline (BiL) Updates

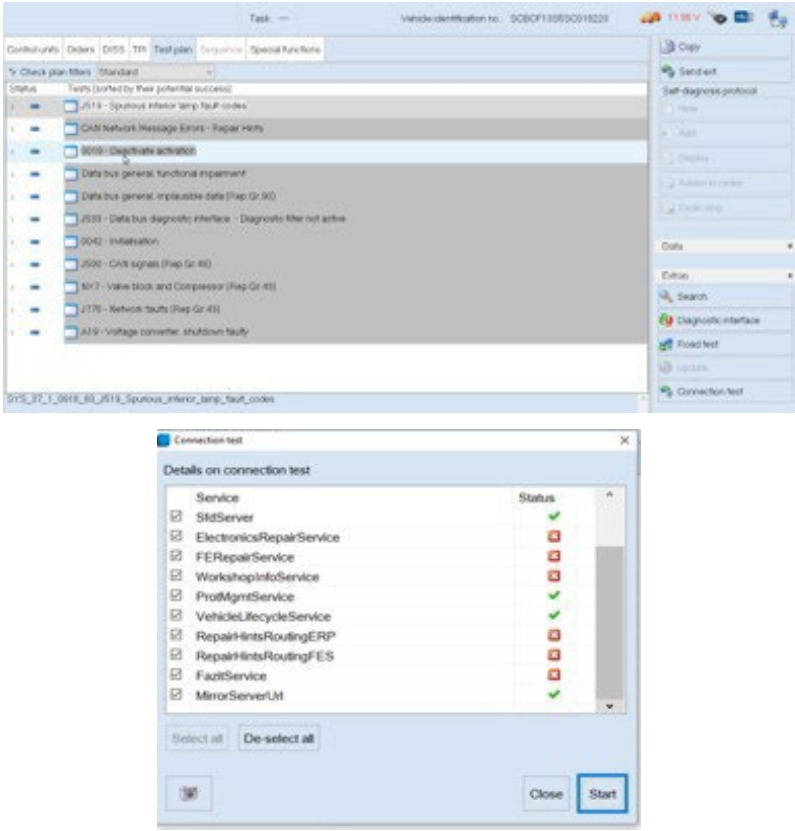
Step	Action	Images
<p>Check that the D3 Edge Box is connected</p>	<ul style="list-style-type: none"> • Perform the 'connection test' within the extra menu <ul style="list-style-type: none"> – Navigate to "Extras" -> "Connection Test" -> Select "Bentley" (If Multi Brand) -> "Select ALL -> Start – If the Mirror Server does not return a green ✓ -> Check your D3 setup and IP settings as per the next step.

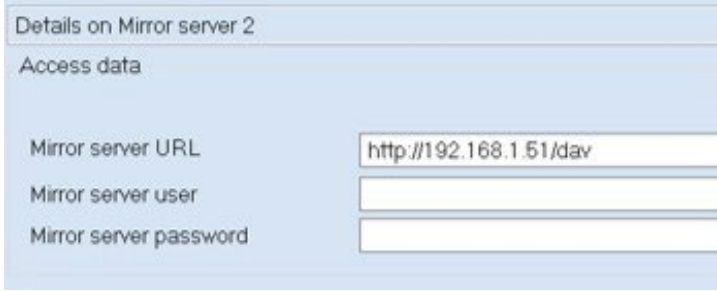
<p>Mirror Server Settings</p>	<ul style="list-style-type: none"> • Check that the URL in the Mirror Server 2 is correct for the new D3 edge box. <ul style="list-style-type: none"> – Refer to "Operating Modes" -> "Admin" -> "Connections" -> "Mirror Server 2;; • Ensure that the URL is http://.. And NOT https:// • Enter the mirror server URL into a web browser, and ensure that the flash files are visible on the server.

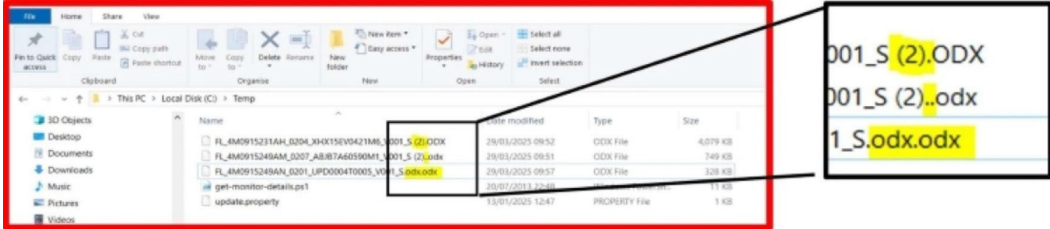
Type of Flash Container	Best Fixes
<p>Local Flash Containers (Using files from c:/temp)</p>	<ul style="list-style-type: none"> If a flash file is being used locally, eg ED40, ED42 download from atheer – this means that the flash container is extracted directly form the C:/temp folder on the users ODIS tester. If the flash files are downloaded incorrectly, or not extracted from the ZIP folders correctly, this means ODIS cannot identify the correct flash file. <p>Example of Bad file structure / naming:</p>

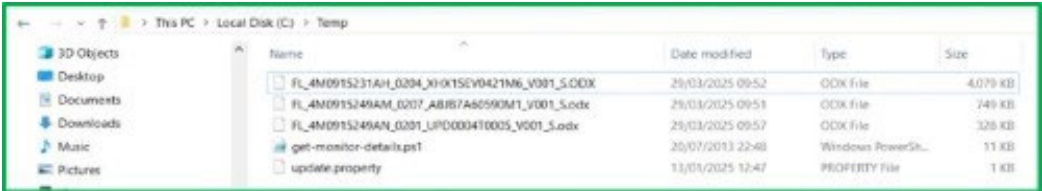
<ul style="list-style-type: none"> Duplicated Download Suffix Multiple or incorrect file extension types

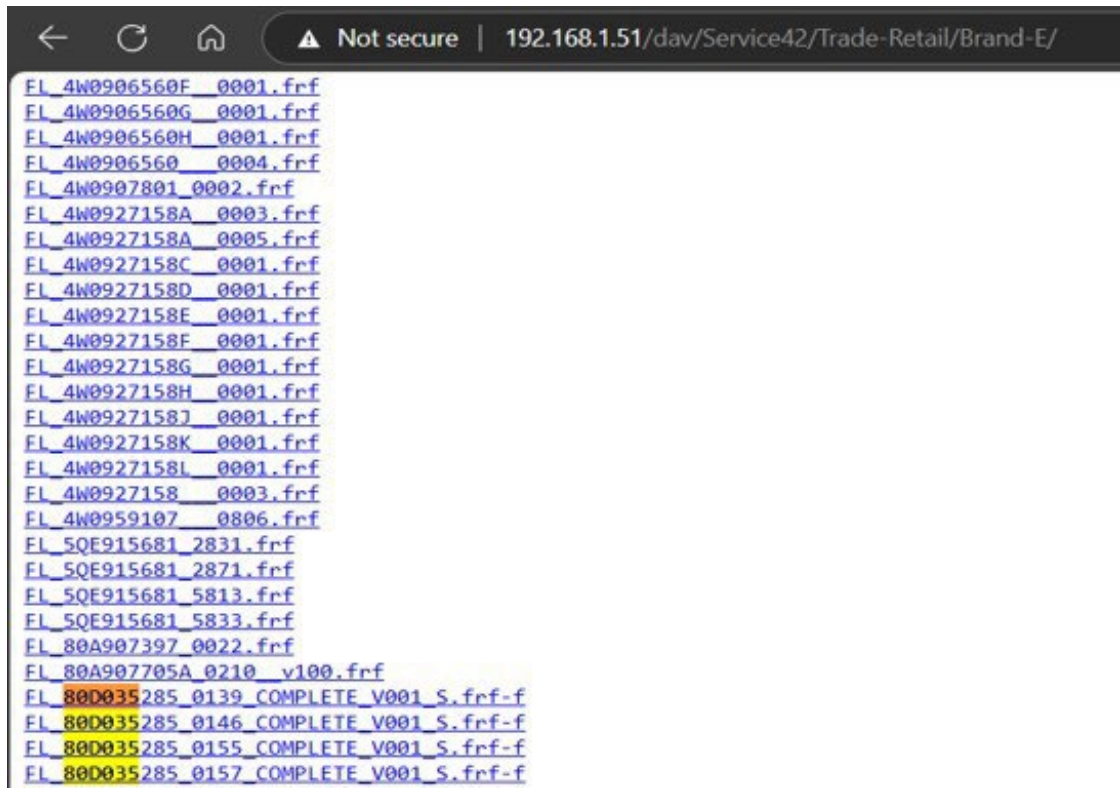
Type of Flash Container	Best Fixes
<p>Online Link Flash Containers (using an SVM Code)</p>	<ul style="list-style-type: none"> • When an ECU requires a software update through SVM, ODIS will pull the file from the mirror server/ D3 edge box. • If the Flash Container can not to be linked, check if the files is present on the mirror server • To do this: <ul style="list-style-type: none"> – Enter the mirror server URL into a web browser, and ensure that flash files are visible on the server. – Copy & paste the mirror server address into a web browser (eg Microsoft edge) -> Navigate to the flash files location: XXX.XXX.X.XX/dav/Service42/Trade-Retail /Brand-E/ • Then press 'ctrl' + 'f' and search the Mirror Server for that flash container. • In this example, the FRF file is available to be flashed with ODIS:
