Technical product information

Topic	Steering rack diagnosed as faulty (Requires replacement) - Guidelines prior to replacing the steering rack
Market area	Bentley: worldwide (2WBE),China 796 VW Import Comp. Ltd (Vico), Beijing (6796)
Brand	Bentley
Transaction No.	2072029/3
Level	EH
Status	Released for publishing
Release date	March 17 2026

Bentayga

Transaction No.:
2072029/3

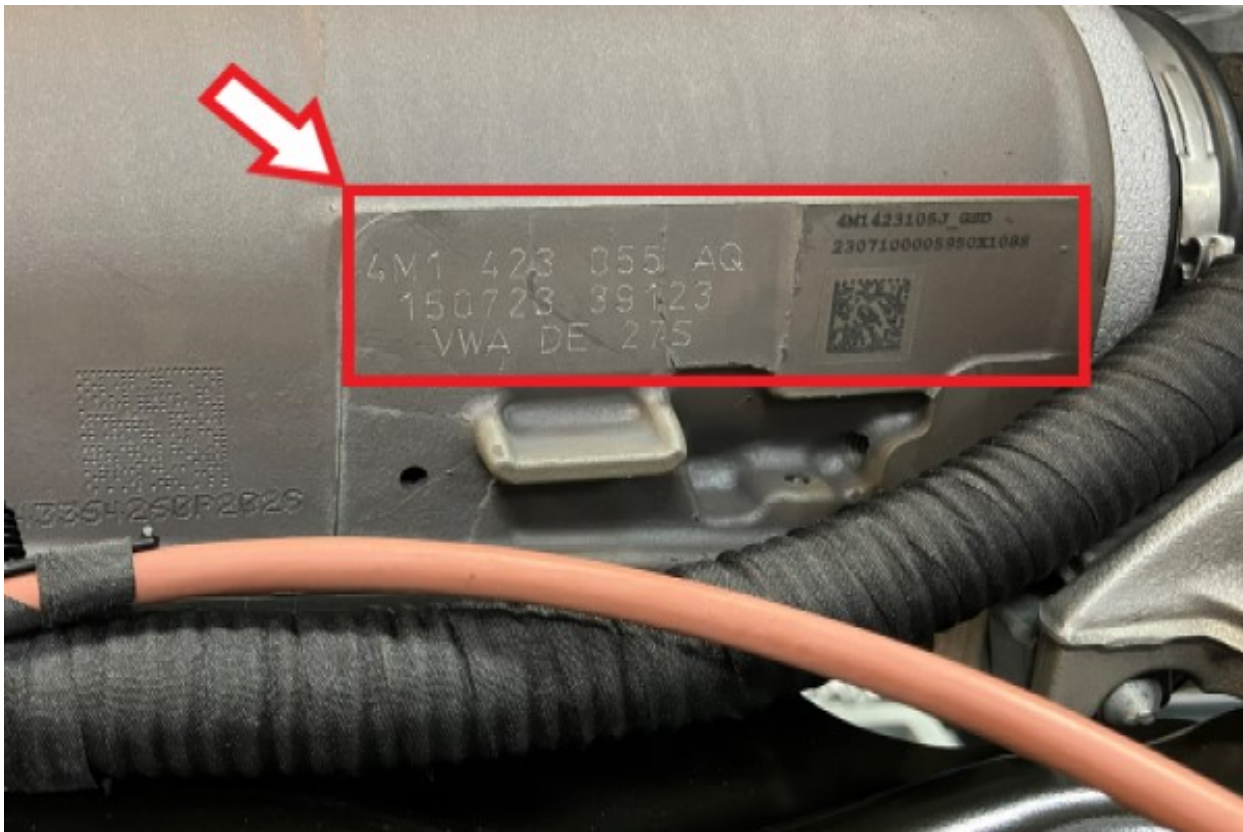
Figure 1

- Clear description of the issue for example - Noisy steering rack
- Clear video of the issue
- Clear photograph of the steering rack serial numbers (Figure 1)
