Technical product information

Topic	Engine Coolant Bypass Valve Control Fault - DTC P268100 with symptom code 32827 evident in address 00C5
Market area	Bentley: worldwide (2WBE),China 796 VW Import Comp. Ltd (Vico), Beijing (6796)
Brand	Bentley
Transaction No.	2081300/1
Level	EH
Status	Released for publishing
Release date	March 23 2026

Engine Coolant Bypass Valve Control Fault - DTC P268100 with symptom code 32827 evident in address 00C5

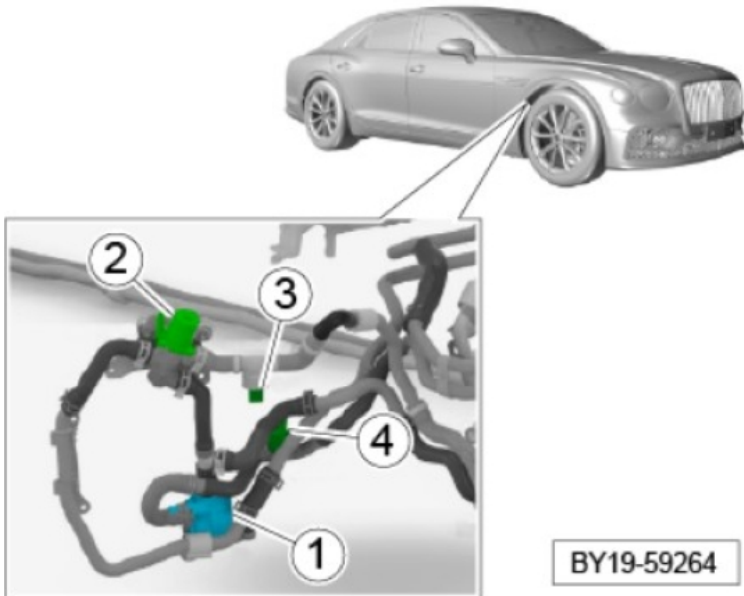
Figure 1. *Coolant Pump Solenoid Valve N91 location*

The coolant pump solenoid valve 4 "(N91)" -2- is located within the front right wheel arch. Disregard all other positions, image for illustration purposes only.

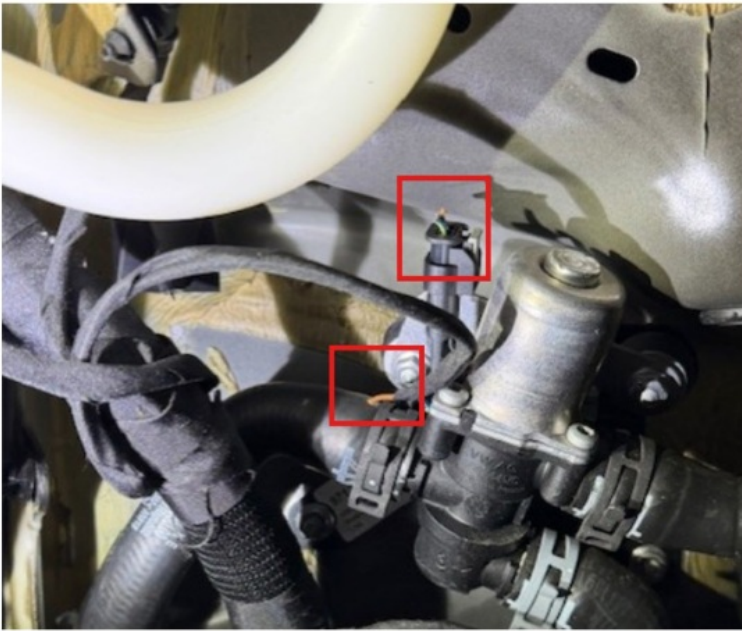
Figure 2. Example wiring damage

DTC P268100 is logged when the engine control module detects an open circuit in the coolant bypass valve control system. Field cases show this is commonly caused by wiring harness damage or poor connection at Coolant Pump Solenoid valve N91, resulting in intermittent or lost electrical continuity

7. If any damage is found see example below (figure 2),

Do not repair without instruction.

Please raise a full technical DISS query for second-level review by the Electrical TM and wait for further guidance.
