Technical product information

Topic	Headlamp Control Unit Replacement Bentayga and Flying Spur 20,21,22,24,25,26MY
Market area	Bentley: worldwide (2WBE),China 723 Volkswagen (Anhui) Automotive CO (6723),China 796 VW Import Comp. Ltd (Vico), Beijing (6796)
Brand	Bentley
Transaction No.	2071933/4
Level	EH
Status	Released for publishing
Release date	March 23 2026

Headlamp Control Unit Replacement | Bentayga and Flying Spur |
20,21,22,24,25,26MY

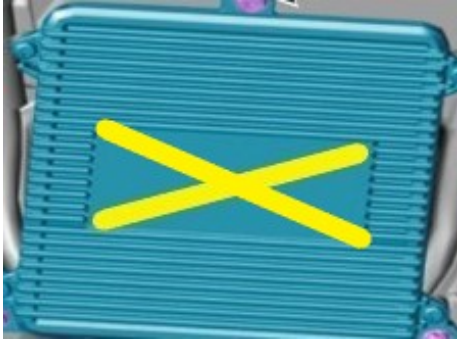
Figure 1

The headlamp control unit can only be replaced a **MAXIMUM** of **TWO** times (per headlamp) If there are two yellow paint marks on the control units (Figure 1) or the vehicles repair history shows the control units have been replaced **TWICE**, a new headlamp assembly is required

The complete headlamp assembly should only be renewed if the replacement of the control unit was not successful

The control unit has been replaced **TWICE** previously (see note below)
