Technical product information

Topic	DTC B101629 and/or B12F129 and/or B151329 evident with 0015 (Airbag) with Airbag Indicator Lamp - Illuminated
Market area	Bentley: worldwide (2WBE),China 796 VW Import Comp. Ltd (Vico), Beijing (6796)
Brand	Bentley
Transaction No.	2080902/2
Level	EH
Status	Released for publishing
Release date	March 27 2026

DTC B101629 and/or B12F129 and/or B151329 evident with 0015 (Airbag) with
Airbag Indicator Lamp - Illuminated

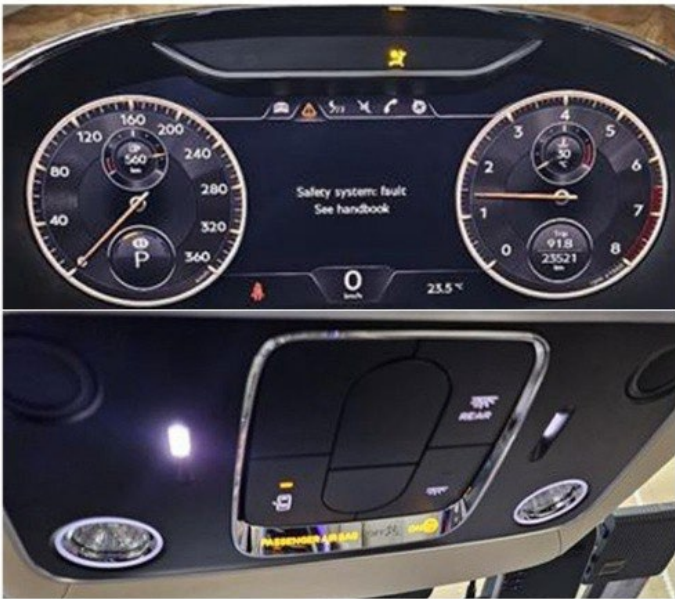
The customer reports that the airbag warning lamp is illuminated in the instrument cluster and the front passenger airbag indicator lamp within the roof console does not function.

Figure 1. Airbag warning illuminated in the instrument cluster

Customer findings of airbag warning lamp illuminated in the instrument cluster verified in the workshop with the following DTCs stored in the airbag control module (address word 0015):

- B101629: Front passenger airbag - disabled- indicator lamp implausible signal – symptom code 9442857
- B12F129: Front passenger airbag -enabled- indicator lamp implausible signal – Symptom code 9629993
- B151329: Front Passenger airbag indicator lamp, text illumination implausible signal – symptom code 9769769

An implausible signal from the passenger airbag indicator is being reported to the airbag control unit. This behaviour is consistent with a connection or fitment issue at the roof console indicator module. A connection check and module fit inspection is required. Refer to the *Measure* section for the approved service action.

1. Inspect the roof console module and ensure the housing is fully clipped together.

Gaps or incomplete assembly may cause the indicator not to function.

2. Remove the front roof console module, check all electrical connectors at the roof console module.

3. Confirm terminals are fully seated, check for bent, recessed or damaged pins

4. Disconnect and reconnect the roof console module.

5. Clear DTCs and recheck operation.
