<b>Topic</b>	Turbo Charger Under-boost - DTC P029900 is evident in 0001   V8 Kovomo   All Models
<b>Market area</b>	Bentley: worldwide (2WBE),China 796 VW Import Comp. Ltd (Vico), Beijing (6796)
<b>Brand</b>	Bentley
<b>Transaction No.</b>	2079115/2
<b>Level</b>	EH
<b>Status</b>	Released for publishing
<b>Release date</b>	March 27 2026

Turbo Charger Under-boost - DTC P029900 is evident in 0001 | V8 Kovomo | All Models

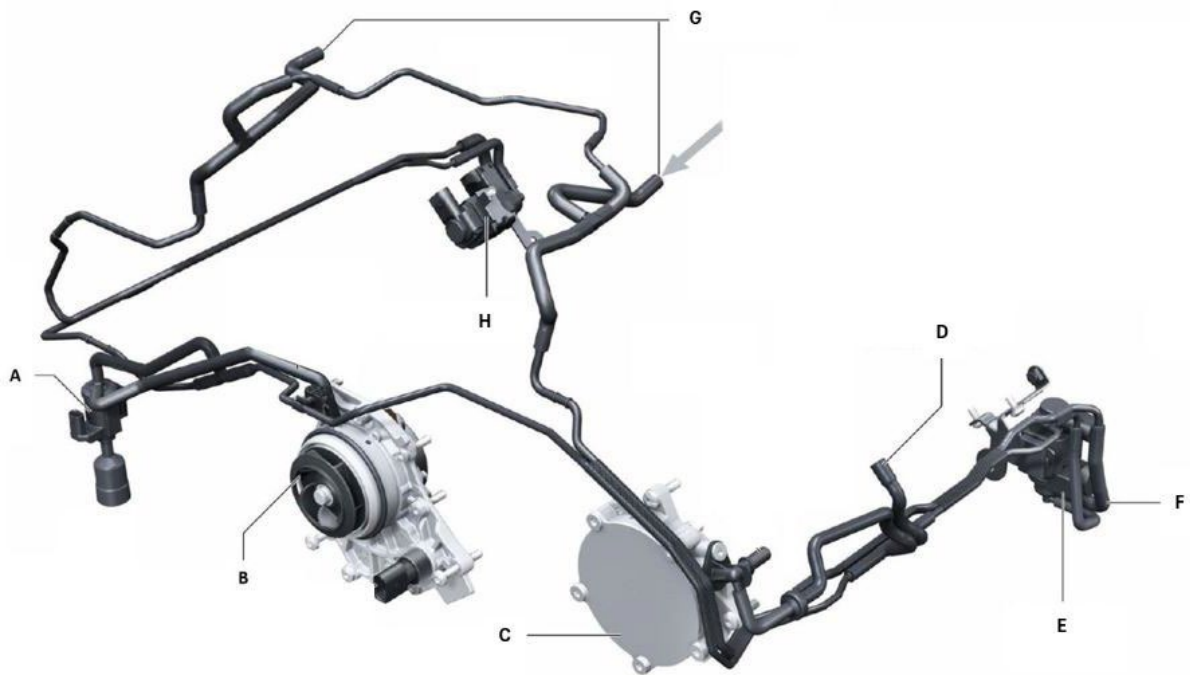
**Vacuum System Layout – Use for illustration purposes only**

The wastegate actuator relies on vacuum pressure to regulate turbocharger boost. If vacuum is not maintained, the wastegate may remain open, preventing the turbocharger from generating full boost. This can trigger engine protection mode, limiting performance and displaying warnings in the DIP. Refer to the measure section for guided fault-finding steps.

A) Switch valve for mechanical coolant pump	B) Coolant Pump	C) Vacuum pump	D) Connection for vacuum reservoir
E) Boost pressure control solenoid 1	F) Outlet (Vacuum pressure input)	G) Connection for Vacuum unit/turbo charger	H) Boost pressure control solenoid 2
