UPDATE PRIOR TO SALE NOTICE

Global Service Action
Number: D093 UPS0726-2

Subject: V8 Badge Not Installed	Publication No.: D093 UPS0726-2
	Model: Range Rover Sport (L1)
	Model Year: 2026
	Date of Issue: 18 March 2026
	Expiry Date: 30 March 2028

SERVICE INSTRUCTION - D093 UPS0726-2

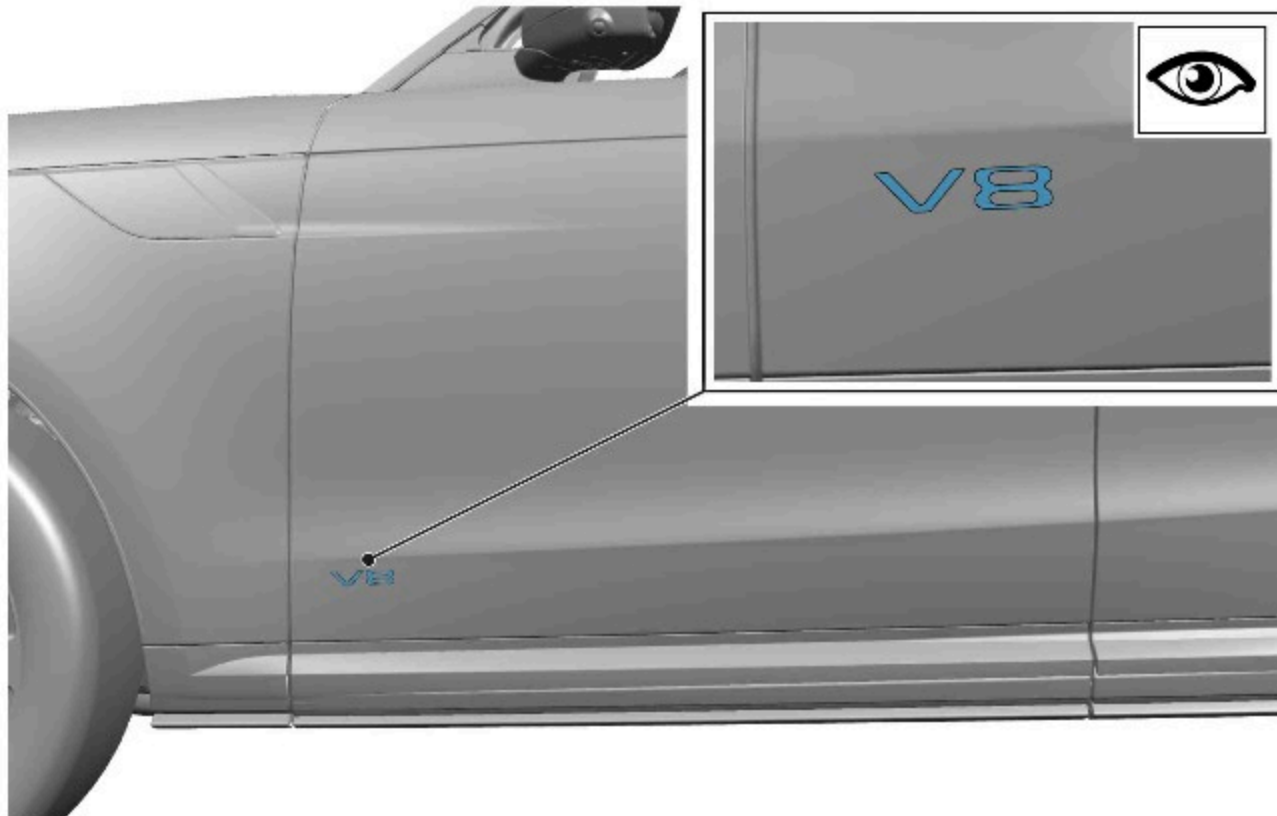
E409131

1. Inspect the left side and right side front doors in the area shown in the illustration.

- If the V8 badge **IS** installed as shown in the illustration, do not continue with the D093 campaign. Release the vehicle.
- If the V8 badge **IS NOT** installed as shown in the illustration, continue to step 2.
