UPDATE PRIOR TO SALE NOTICE

Global Service Action
Number: D108
UPS1226-2

Subject: Front Stabilizer Bar (Vehicles With Electric Dynamic Response) Concern	Publication No.: D108 UPS1226-2
	Model: Range Rover (LK)
	Model Year: 2026
	Model: Range Rover Sport (L1)
	Model Year: 2026
	Date of Issue: 20 March 2026
	Expiry Date: 31 March 2028

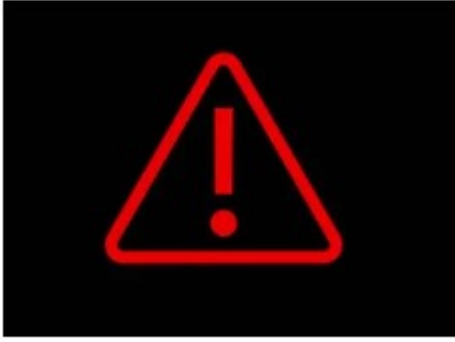
E412478

5. Inspect the vehicle instrument cluster for a **RED** warning lamp, as shown in the illustration, accompanied by the following warning message: '**Stop safely suspension fault detected**'. Check for the following [DTCs](#) in the [CHCM](#): C1046-62 or C1046-64.

- If there **IS** a red suspension warning and / or at least one of the listed [DTC](#) present, a new front stabilizer bar must be installed. Continue to the Service Instruction.
- If there **IS NOT** a red suspension warning and the listed [DTCs](#) are **NOT** present, continue to the next step.

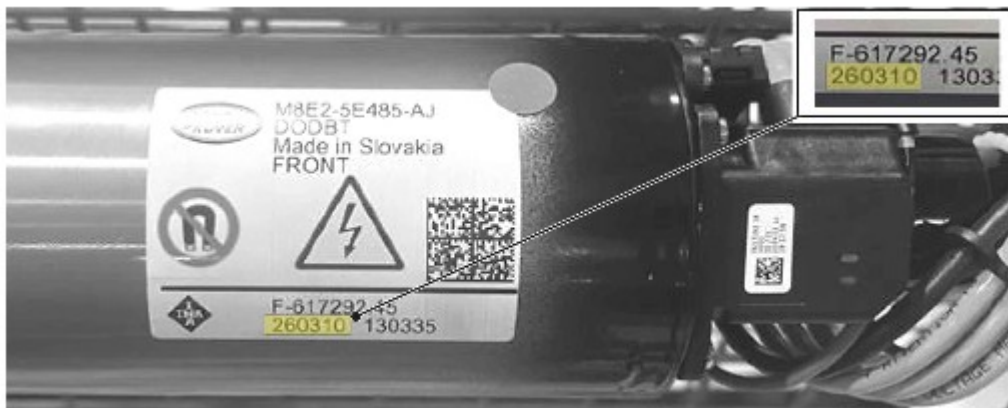
E41233B

Inspect the date on the new front stabilizer bar before installation, as shown in the illustration.

- The date configuration is **Year / Month / Day**.
- If the date on the new stabilizer bar **IS** within the following range - '**25 / 12 / 18**' to '**26 / 02 / 02**', - **DO NOT** install the new stabilizer bar. Return the stabilizer bar and order a replacement. New stabilizer bars that fall within the stated date range may be faulty.
- If the date on the new stabilizer bar **IS NOT** within the following range - '**25 / 12 / 18**' to '**26 / 02 / 02**', - continue to step 2.

2. Renew the front stabilizer bar, (see TOPIx workshop manual section 204-01: Front suspension - Removal and Installation - Front Stabilizer Bar).
3. Connect the JLR approved diagnostic equipment and the approved battery support unit.
4. Run the 'Front [Active Roll Control Module \(ARCM\)](#) - Front [ARCM](#) Pairing To Front Stabilizer bar'. Refer to: [Front ARCM - Front Active Roll Control Module \(ARCM\) Pairing To Front Stabilizer Bar](#) (204:00/FARC,).
5. Run the 'Front [ARCM](#) - Front [ARCM](#) Pairing To [CHCM](#)'. Refer to: [Front ARCM - Front Active Roll Control Module \(ARCM\) Pairing To Chassis Control Module \(CHCM\)](#) (204:00/FARC,).
6. Clear all [DTCs](#). Refer to: [Clear All DTC\(s\)](#) (100:00, General Procedures).
