WSJ0 – Update to Software Network VR28.13 (Workshop Campaign)

Model Year: **As of 2023 up to 2025**

Model Line: **Macan Electric (XAB)**

Concerns: **Software update (software version VR28.13)**

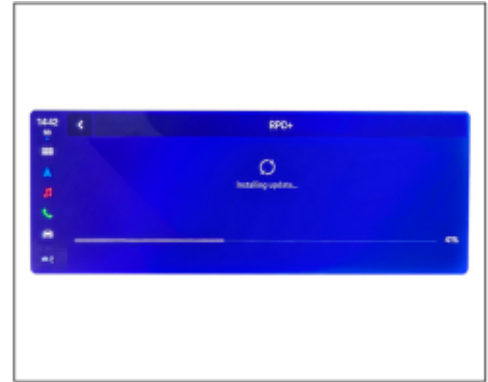
Update progress on central display
