L634-
A.07.26

To: After Sales Official Network
Subject: HV coolant pipe wrong routing
Date: 06/03/2026
Pages: 6

Campaign code:
L634-A.07.26

Campaign name:
HV coolant pipe wrong routing

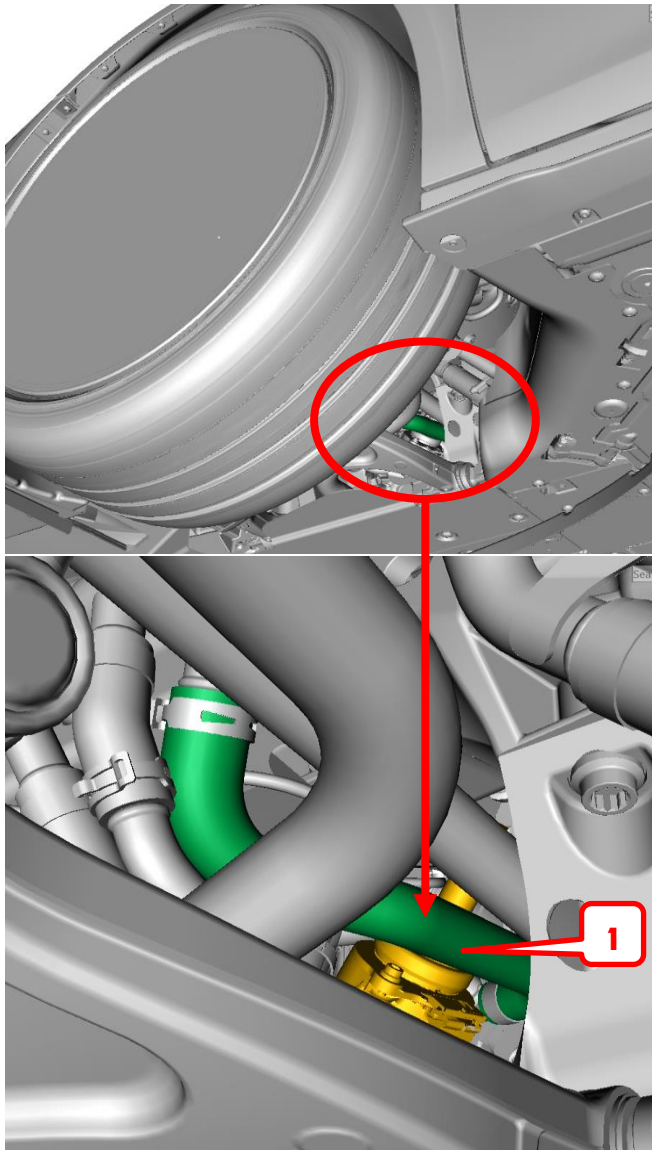
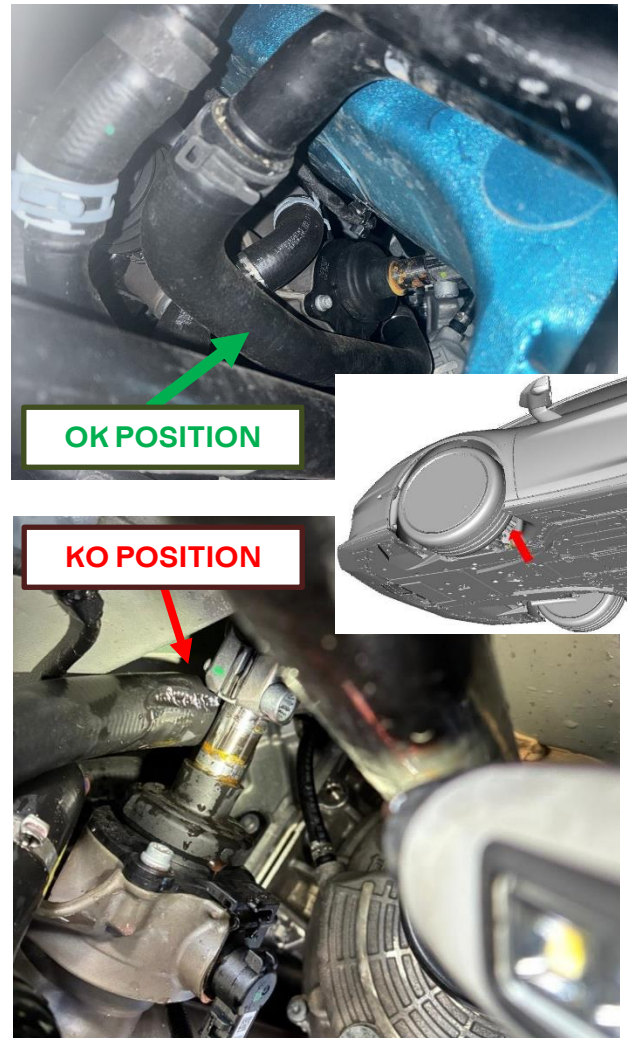
During ongoing product monitoring, Automobili Lamborghini S.p.A. noted that HV coolant pipe may have a wrong routing

1. Raise the car.
2. Turn the wheels fully to the right.
3. From the front left wheel, check that the HV cooling pipe (1) is correctly positioned.
4. If the pipe (1) passes under the steering box rack, the routing is correct (see *OK position* figure).

5. If the pipe (1) passes over the steering box rack, the routing is incorrect (see *KO position* figure).

- If the pipe is damaged, proceed with **operation B** to replace the pipe
- If the pipe is not damaged, please perform the pipe (1) repositioning with **operation C**.
