Y1A, Y1B, Y1C- High-Voltage (HV) Battery Measurements during HV Battery Repair

Vehicles Affected

Models	Model Year	Model Type	VIN Range	Vehicle-Specific Equipment
Taycan	All	Y1A, Y1B, Y1C	All	N/A

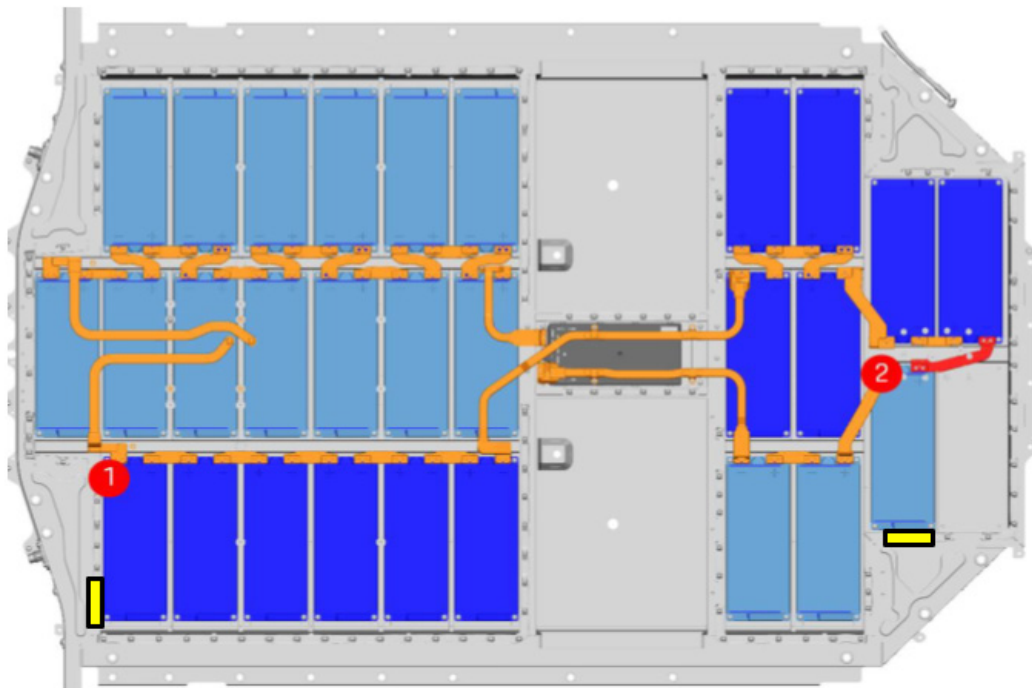
Figure 1 - 28-module HV Battery measurement points

- Only two DSTs are to be performed on a 28-module battery pack during repair.
- The busbar indicated in red must be removed prior to measurements at either point.

- Perform an IR test at points 1 and 2 before the DST at those points.
- Perform a DST only at points 1 and 2 shown below for each repair scope.
- The yellow boxes in *Figure 1* designate the sections of frame where a lid screw can be hand-started to ground the dielectric strength tester.

- Also perform IR tests at points 1 and 2 after a DST, with the negative probe in contact with a clean spot on the silver frame surface designated by the yellow boxes.

- If the final IR test at measurement point 1 fails, remove busbars and CMC connections from each module shaded in dark blue for further IR testing as described in the following *Updated IR Measurement Procedure* sections.

- If the final IR test at measurement point 2 fails, remove busbars and CMC connections from each module shaded in light blue module for further IR testing as described in the following *Updated IR Measurement Procedure* sections.

- EXAMPLE: Point 1 passes DST and point 2 fails.
 - Perform IR tests on each light blue module in the failing section (In this example, section 2). No additional work is required for the passing modules in section 1.

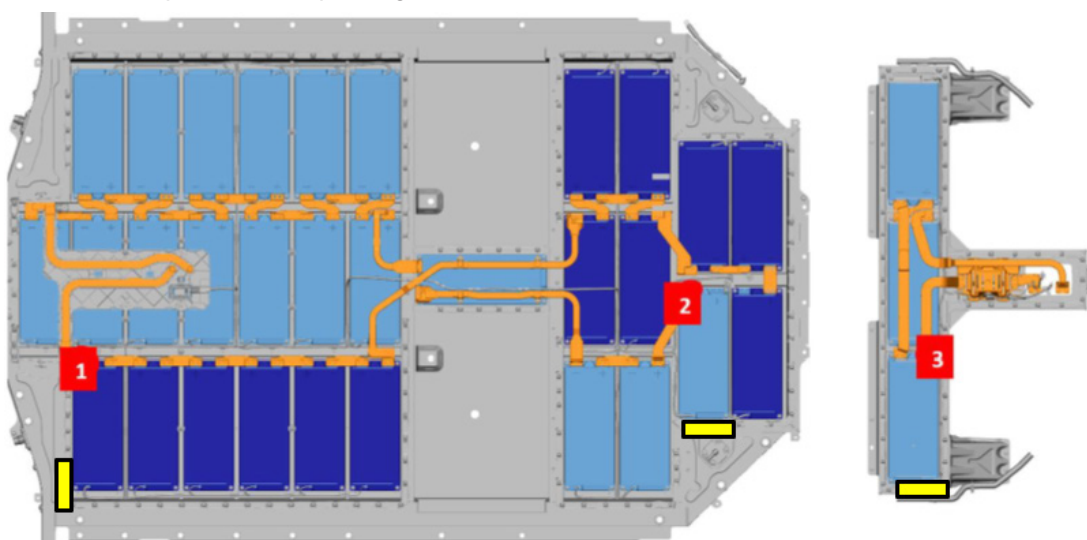
Figure 3 - 33-module HV Battery measurement points

- Only a total of three or four DST's are to be performed on the 33-module battery pack during repair, depending on scope.
 - ▷ Perform a DST only at points 1, 2, and 3 for any repair scope involving the lower-level modules.

- ▷ Repair scopes in only the upper "T" section require an initial DST (in addition to the points in *figure 2*) at the mid-pack fuse as shown in step 3.9.3 of Safety test after assembly work on the high-voltage battery with 33 modules in WM 270803A5. Only proceed with removing lower lid if this initial DST fails.

- If removed, the upper "T" Section should be placed aside on a VAS 6762/44 Insulating mat during testing.
- Perform an IR test at points 1, 2 and 3 before the DST at those points.

- The yellow boxes in *Figure 3* designate the section of frame where a lid screw can be hand-started to ground the dielectric strength tester. If performing a DST on the mid-pack fuse, use the location on the upper "T" section to ground the negative clamp.

- Perform IR tests at points 1, 2, and 3 after a DST, with the negative probe in contact with a clean spot on the silver frame surface designated by the yellow boxes.

- If the final IR test at measurement point 1 fails, remove busbars and CMC connections from each module shaded in dark blue for further IR testing as described in the following *Updated IR Measurement Procedure* sections.

- If the final IR test at measurement point 2 fails, remove busbars and CMC connections from each module shaded in light blue for further IR testing as described in the following *Updated IR Measurement Procedure* sections.

- If the final IR test at measurement point 3 fails, remove busbars and CMC connections from each module in the upper "T" section for further IR testing as described in the following *Updated IR Measurement Procedure* sections.

- EXAMPLE: It is possible for battery to have point 1 pass, point 2 pass, and point 3 fail the DST. It would then only be required to perform further IR tests on each module in the upper "T" section. No additional work would be required for the passing lower sections.

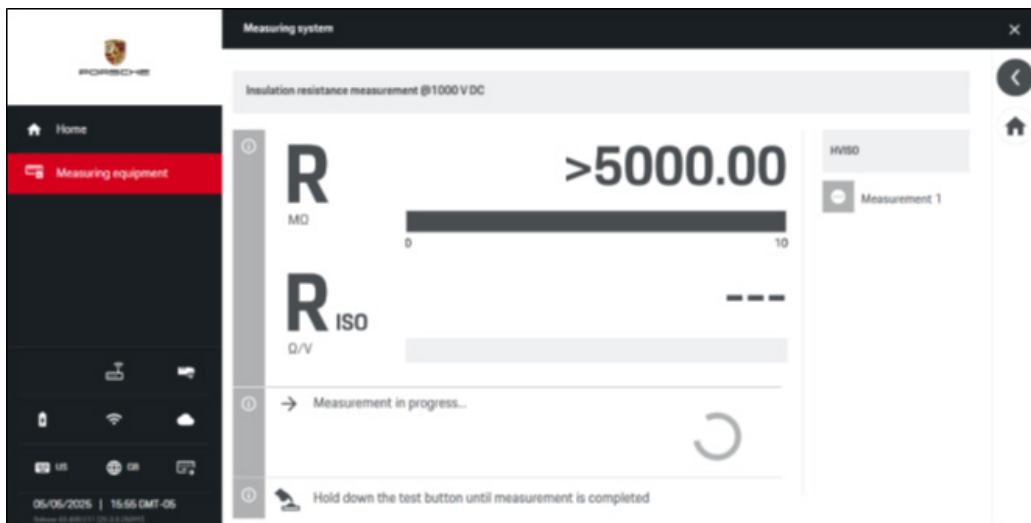
Figure 7 - Insulation resistance measurement in PIWIS Tester

- Shown below is an example of passing test result of >5000 MΩ. This is the reading displayed when IR measures above the 500 MΩ measuring threshold.
- IR values between 200 MΩ and 500 MΩ are also acceptable for the second measurement on a terminal.
- If the first IR test on either module terminal fails, but the second one passes, the module is okay and should not be replaced.
- If any second terminal IR test shows a number below 200 MΩ, this is considered a failure.
- If IR is below the measurement threshold, the IR test won't complete in the measurement equipment display. If the IR test fails to produce a value after multiple attempts on any module terminal, replace it.
- Document any failures in the "Module insulation Resistance Template" Excel file attachment and attach to the repair PCSS entry.
