Macan Electric (XAB) – AC Charging at Home Not Possible after WSJO

Model	Model Year	Model Type	Vehicle-Specific Equipment
Macan Electric (XAB)	2024-2025	All	N/A

Revision	Release Date	Change
0	March 20, 2026	First Publication

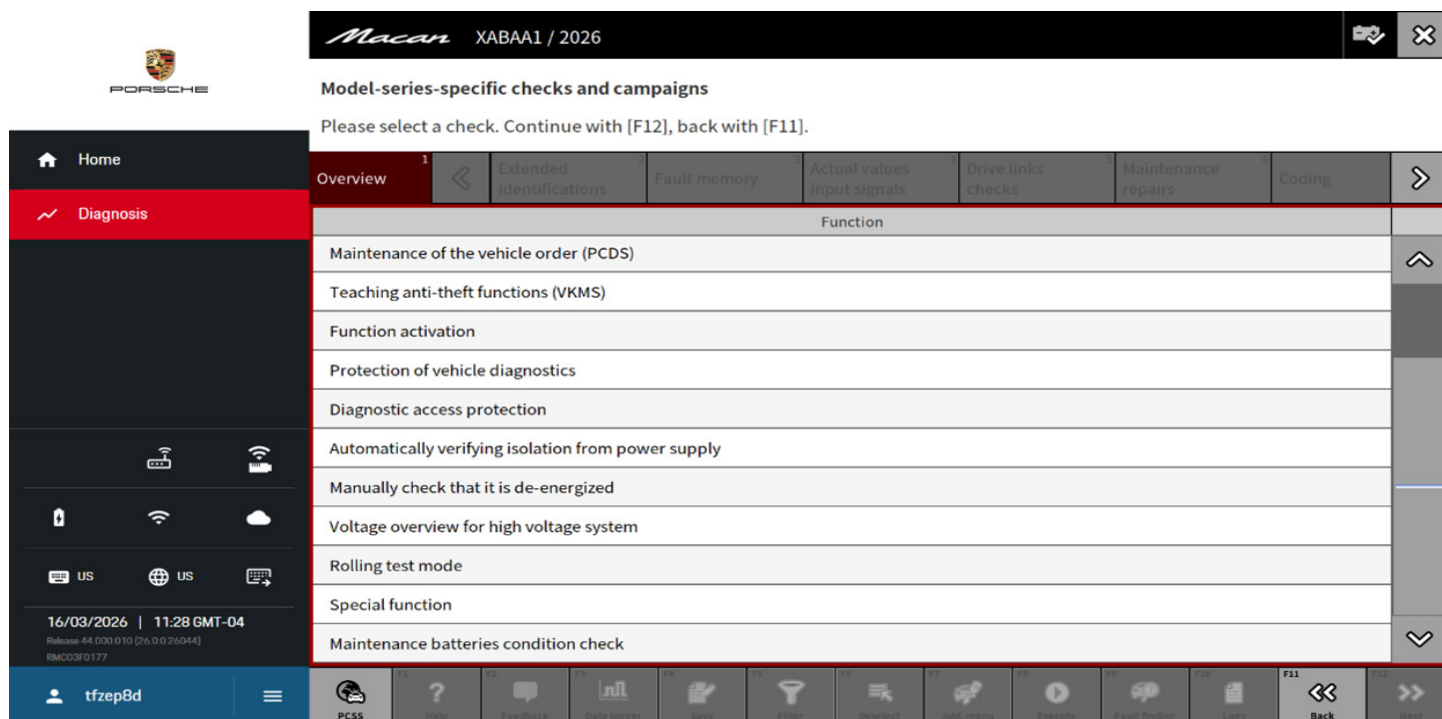
1. Verify that the vehicle is able to AC charge in the workshop
2. Create a VAL
3. Use the Special Functions Tab of the Additional Menu [F7] to begin the programming procedure.
4. Read and follow the information and instructions on the PIWIS Tester during the guided programming sequence. A VAL will automatically be created after the programming is completed.

5. Verify the SW level is changed to 0346
6. Verify that the vehicle is still able to AC Charge at the workshop
