E326: EPA 17-24 MX-13 Fuel Injector Connector Upgrade

E326

3/6/2025

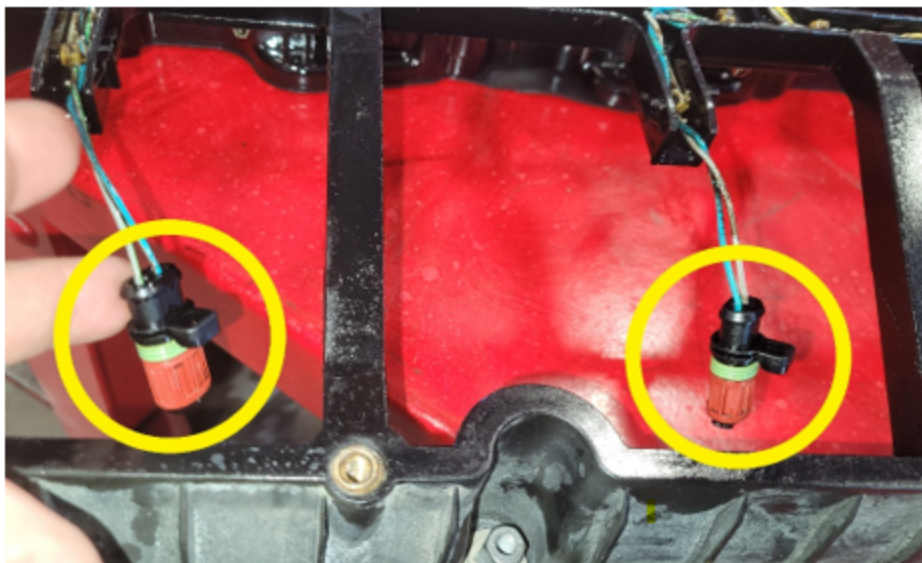
During repairs which involve disconnecting the injectors or removing the valve train casing, the injector connector shells (1439888PE) locking tabs may be broken. Since the injector connector shells were not

previously available, the entire valve train casing assembly had to be replaced to fix the issue.

Broken Injector Connectors in Valve Train Casing Assembly

To prevent downtime, dealers should stock the injector connector shells (1439888PE). Replacement of broken connector shells should occur rather than replacement of the valve train casing assembly.

Injector connector shell replacement procedures can be found in RMI by searching “valve train casing”, then select Parts > Valve train casing > Jobs > replace 1 (one) connector 2-pin (Basic assembly).

When connector shells are replaced according to RMI, a pin extraction tool is required to complete the repair. This tool is part number 539972-1, available through PACCAR Parts.
