INSTRUCTION TO SERVICE

ITS- 61619		03/16/2026
SECTION:	220 - Traction Motor and Drive Shaft.	
SUBJECT:	Driveshaft Guard Incorrect Mounting Hardware	
ISSUE:	Vendor supplied assembly with Stainless Steel bolt instead of grade 8 Carbon Steel Bolt.	
CORRECTIVE ACTION:	Replace driveshaft guard mounting hardware.

ITS-61619

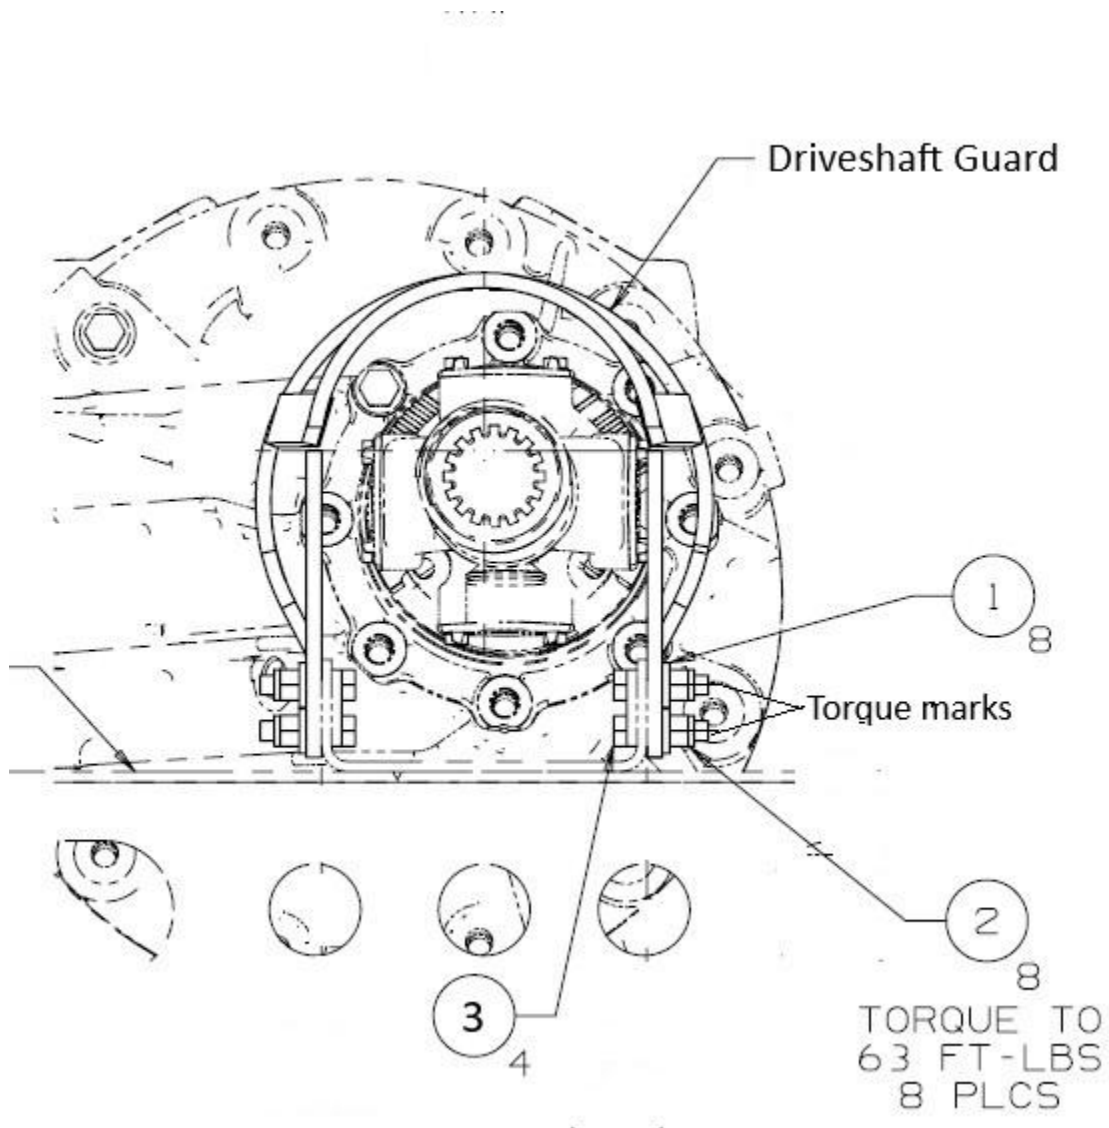
Figure 1: Driveshaft guard installation reference.

1. Locate the driveshaft guard and remove the ½ hex nut (x8), ½ flat washers (x8) and bolt assembly (x4). Discard the hardware.
2. Install 4ea. driveshaft guard bolt assembly (Item #3) and secure using 8ea. ½ flat washers (Item #1), and 8ea. ½ hex nuts (Item #2). Torque hardware to 63 ft-lbs. and apply torque indicator marks across the bolt and nuts. See figure 1.
