# Mitsubishi Motors North America, Inc.

## TECHNICAL SERVICE BULLETIN

### UNRESPONSIVE TOUCH SCREEN OF SDA2 AUDIO UNIT - WARRANTY EXTENSION

No: TSB-25-54-002

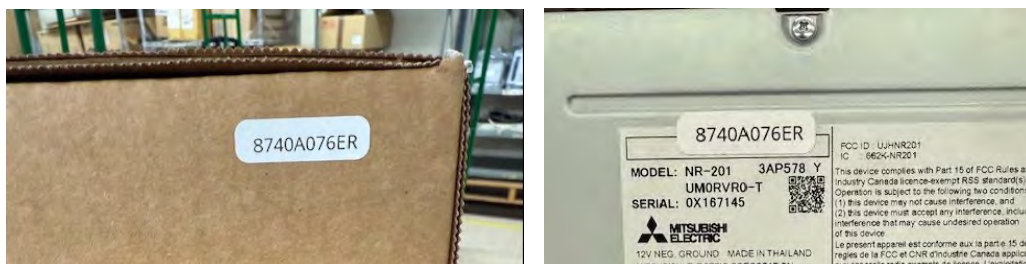
Please note that exchange part numbers are found on both the shipping box and part as shown below:
