## Technical Service Bulletin

GROUP	NUMBER
<b>CAMPAIGN</b>	<b>26-01-034H</b>
DATE	MODEL(S)
<b>APRIL 2026</b>	<b>PALISADE (LX3)</b>

**SUBJECT:** CCU SOFTWARE UPDATE FOR OTA INITIALIZATION  
(LIMITED COVERAGE CAMPAIGN LA20)

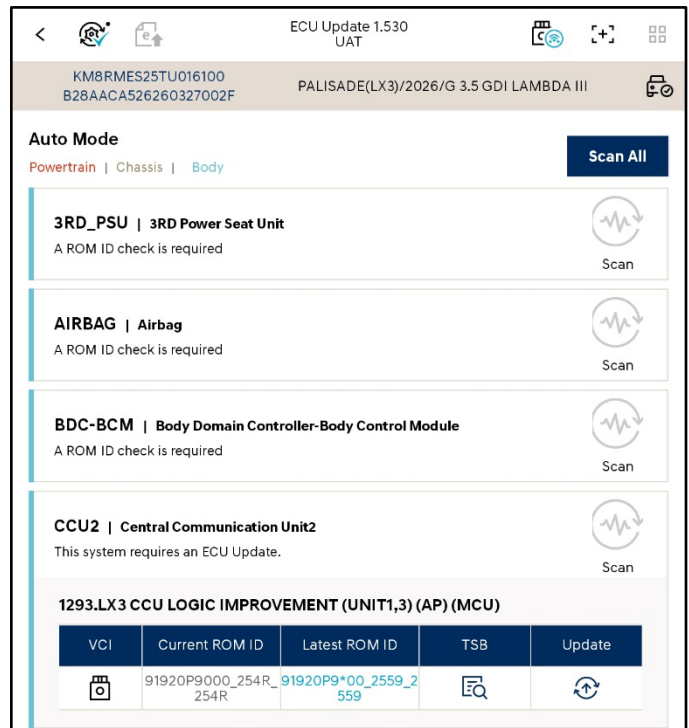
2. Verify the ROM ID by selecting the **CCU2** system to scan the vehicle’s current ROM ID.

Check the current ROM ID version and compare it to the ROM ID Information table before attempting to perform the software update.

If the update fails, remove the power connector from the in-cabin fuse box for at least **5 seconds**. Reassemble and retry the update.
