Countries:	CANADA, MEXICO, UNITED STATES	Document ID:	IK0800691
Availability:	ISIS, Bus ISIS, FleetISIS, NotSIR	Revision:	0
Major System:	Electrical	Created:	3/3/2026
Current Language:	English	Last Modified:	3/24/2026
Other Languages:	NONE	Author:	Sean McGannon
Viewed:	79

Title: Radio Replacements on Vehicles with Fusion 3.0 and/or Blind Spot Monitoring

Applies To: MY 2025, MY2026, MY2027, MY2028 LTs built 7/8/25 and later; MY2025, MY2026, MY2027, MY2028, MY2029, MY2030, MY2031, MY2032 MVs built 2/10/25 and later; MY2025, MY2026, MY2027, MY2028, MY2029, MY2030, MY2031, MY2032 CEs built 4/16/25 and later; MY2025, MY2026, MY2027, MY2028, MY2029, MY2030, MY2031, MY2032 HVs built 10/15/25 and later; with feature codes 08TRM, 08TYA, or 08TYB.

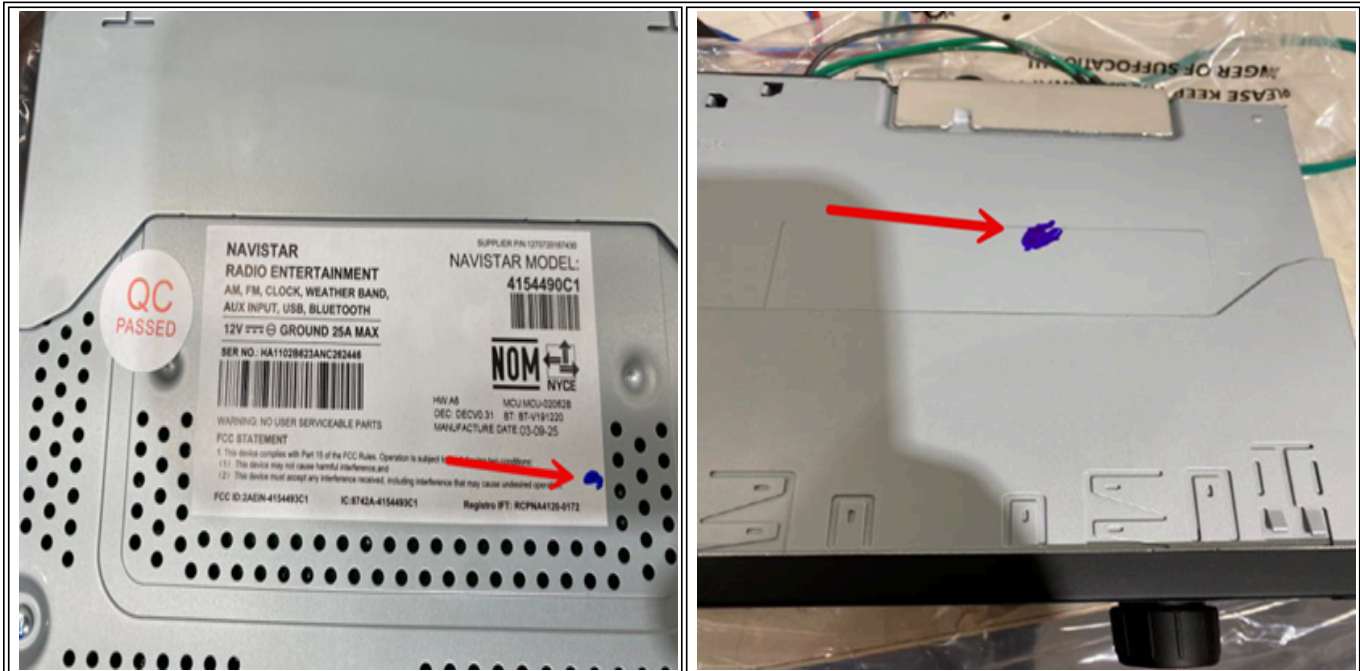
Some earlier-built radios were updated before entering the PDCs. If that is the case, the radio will be marked with a blue or black dot on the radio as shown below.

Blue Marks on Radio Indicating software was updated to support new features.
