Visibility of the Seat Cushion Upholstery When the Seat Cushion Fore/Aft Adjustment Is Extended

Topic number	LI91.10-P-080033
Version	1
Function group	91.10 - Front seats
Date	4/8/26
Validity	The affected cover variants are listed below. Vehicles may be affected until the date specified: Item number Date A 294 910 62 02 9H93 - 20/06/2024 A 296 910 11 05 9E43 - 08/07/2024 A 294 910 53 02 9E38 - 11/07/2024 A 296 910 18 03 8U00 - 15/07/2024 A 296 910 17 03 1D08 - 22/07/2024 A 294 910 22 02 9K65 - 22/07/2024 A 296 910 29 03 9E38 - 05/08/2024 A 296 910 15 03 1D63 - 05/08/2024 A 294 910 23 02 9E38 - 26/08/2024 A 296 910 12 05 1D08 - 23/09/2024 A 296 910 18 03 1D44 - 11/10/2024 A 294 910 53 02 1D44 - 28/10/2024

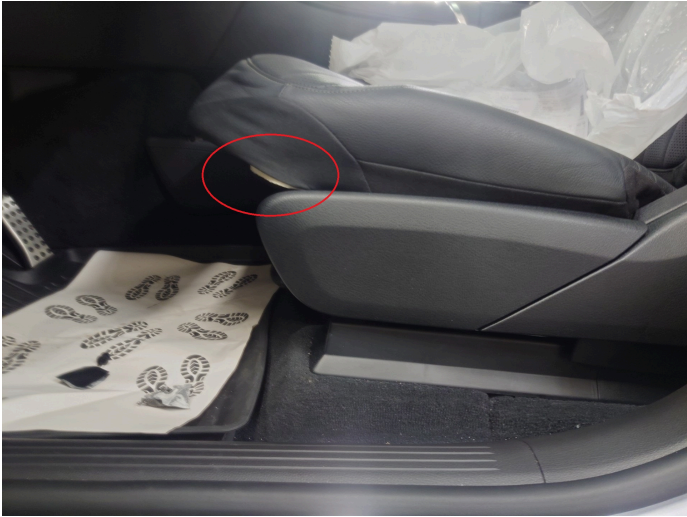
Attachments	
File	Description
Sichtbarkeit Schaumpolster.jpg	Visibility of foam pad

The seat cushion upholstery is visible when the seat cushion fore/aft adjustment (SKTV) is completely extended.

The stretch part of the seat cushion cover does not completely cover the padding.

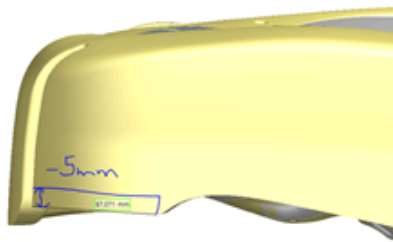
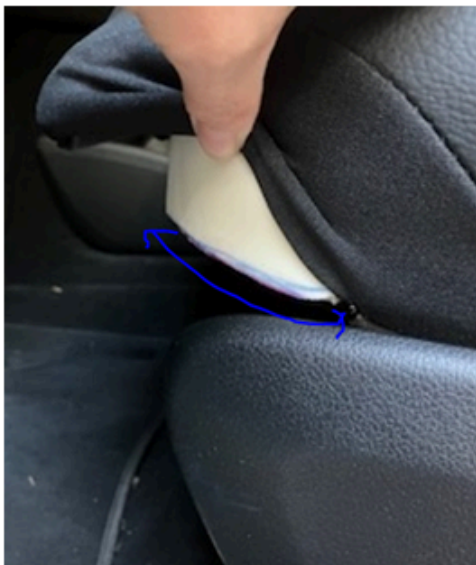
Attachments	
File	Description
BR 294_296 - Schaumteil nacharbeiten.png	Reworking foam part

Seitlich vorne um 5mm in der Höhe kürzen und nach hinten auslaufen lassen

An adaptation must be made to the seat bolster in the form of a cutout. To do this, please proceed as follows:

- Extend the seat cushion fore/aft adjustment (SKTV) 2 times
- Trim the foam to reduce its height by 5 mm. Remove material along the front section up to the start of the profile (approximately 85 mm), then gradually taper the cut toward the rear.
- Extend SKTV 5 more times and check whether visibility is still ensured
- If necessary, lightly rework again

If too much of the foam part is removed, there is a risk that the stretch will become too wavy when retracted.
