Unwiped Area During Downward Wiper Blade Movement

Topic number	LI82.30-P-078932
Version	2
Function group	82.30 - Windshield wipers
Date	4/1/26
Validity	Model series 167 with standard wiper system as from production date 21.10.2022 Tuscaloosa plant, 31.10.2022 CKD
Reason for change	Description updated. further information added

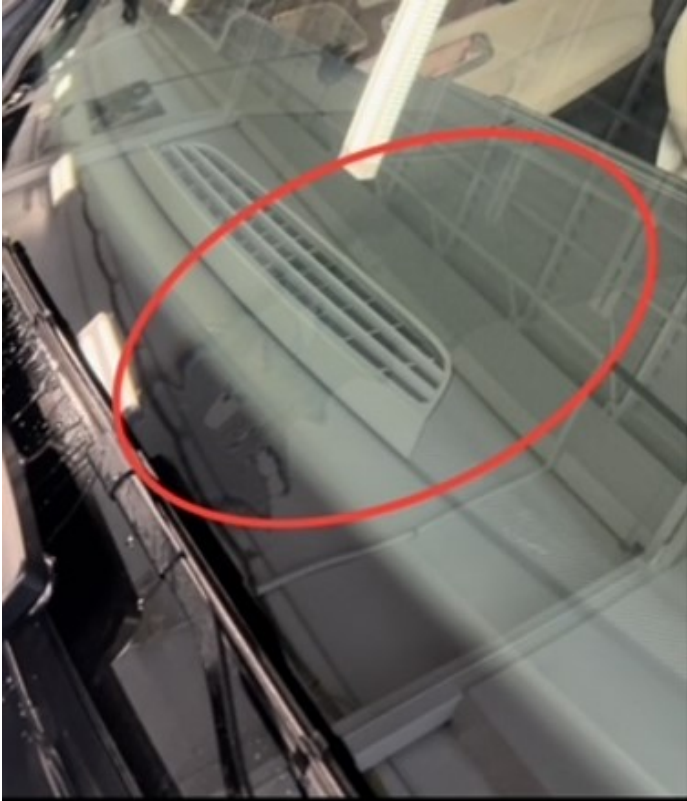
Approx. A 5–10 cm wide unwiped strip remains in the area of the wiper blade attachment during the downward movement of the wiper on the driver's side or front passenger side (see Figure 1).

Attachments	
File	Description
Bild1.jpg	Example: Streaks in the wiper blade attachment area on driver's side

The wiper lip of a wiper blade before switchover is deformed due to the higher contact pressure of the wiper arm, which can result in a 5–10 cm wide strip in the area of the wiper blade attachment not being fully wiped.

Install the correct wiper blades intended for the vehicle
