STAR ONLINE PUBLICATION

Case Number: S2623000020

Symptom/Vehicle Issue: Aux Switches Below Radio Screen Do Not Work.

Models Affected: 2025 Ram 1500 (DT)

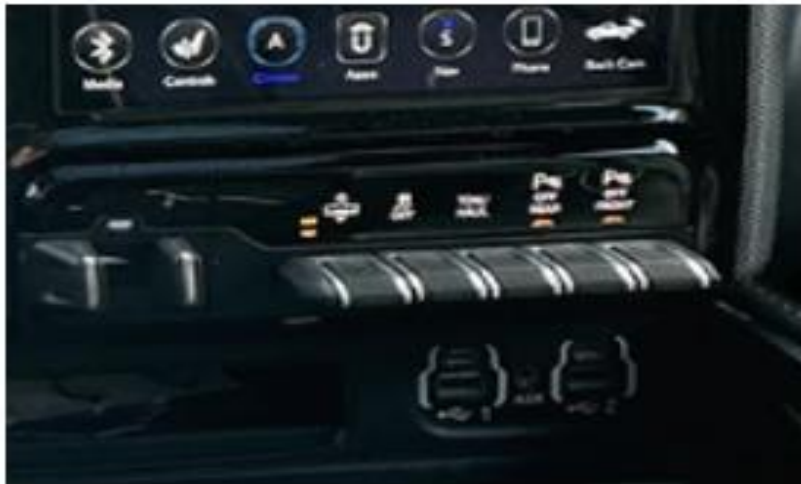
Switch Bank Pod

Customer Complaint/Technician Observation: Park Assist and/or aux function switches are not working in the switch bank. Technician may find diagnostic trouble code (DTC) B1285-2A Park Assist Switch Stuck.

Repair Procedure: Review the below if a customer has a verified concern of the Park Assist and AUX switches are not working in the switch bank pod. Steps listed below should be used in addition to standard diagnostics.

1. Confirm the part number installed matches the current StarParts part listing. The “root number” (the part number without the 2 letter suffix) should match. If the

digits do not match the catalog, replace the switch bank pod with the most current part in StarParts. Then proceed to the Verification portion of this document. If the digits do match, continue to step 2.
