STAR ONLINE PUBLICATION

Case Number: S2323000066

Models Affected: 2022-2026 Wagoneer/Grand Wagoneer (WS)

Symptom/Vehicle Issue: Buzz Squeak Rattle (BSR) From Left Rear Cargo Area Near Subwoofer.

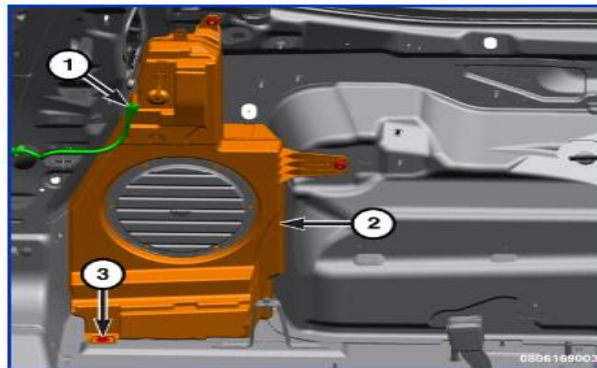
Customer Complaint/Technician Observation: BSR noises over rough roads or with loud music and bass notes coming from inside or outside the rear left cargo area of the vehicle.

1 - Wire Harness Connector

2 - Subwoofer

3 - Subwoofer Fasteners

Discussion: The source of the noise could be related to the subwoofer. Remove the left rear quarter trim panel to inspect the subwoofer installation. Refer to Service Library 08 - Electrical / 8A - Audio/Video/Entertainment/Connectivity / SPEAKER / Removal and Installation Subwoofer. Inspect subwoofer fasteners and harness routing for possible cause of the rattle.
