Unintentional opening of the tailgate – re-coding from long press to double-click

Topic number	LI72.20-P-075746
Version	5
Function group	72.20 - Tailgate, rear door
Date	4/1/26
Validity	118, 167, 177, 206, 213, 223, 238, 243, 247, 254, 257, 293, 294, 295, 296, 297, 214, 236 MOPF: 205, 253, 217, 222
Reason for change	Adaptation BR174/178 Clarification of instructions for key deactivation

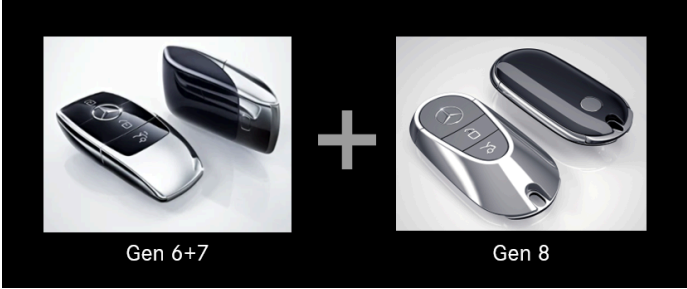
Attachments	
File	Description
Gen 6+7+8 Key.png

6th, 7th and 8th generation keys can be deactivated as follows:

Up to modification year 22/1 by double clicking the "Lock button"

As of modification year 22/1, by press and holding the "Lock button", then double-click the "Unlock button" at the same time.
