TECHNICAL SERVICE BULLETIN

Illuminated MIL With DTCs P2418:72 And/Or P2450 Stored In The PCM

26-2023

Ford 2024-2026 Expedition
Lincoln 2024-2026 Navigator

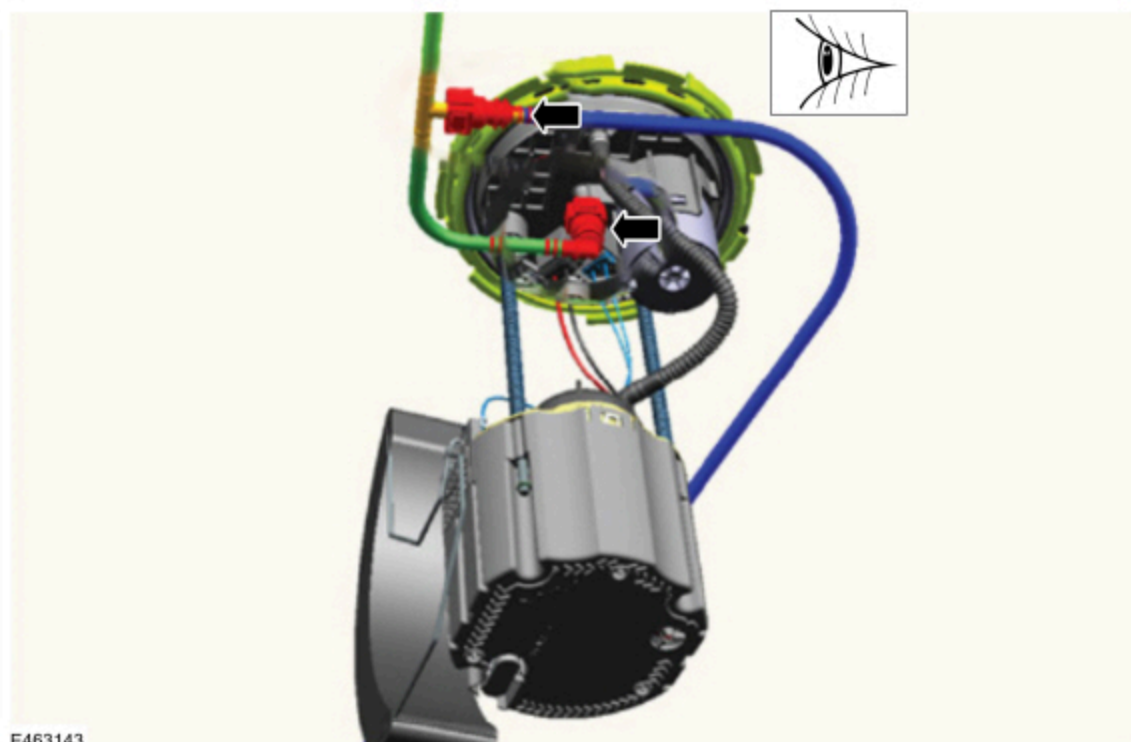
Figure 1

Issue: Some vehicles listed in the Model section above may exhibit an illuminated MIL with DTCs P2418:72 and/or P2450 stored in the PCM. This may be due to improperly connected EVAP line connections inside the fuel tank.

3. Remove the fuel pump and sender unit. Refer to the WSM, Section 310-01 Fuel Tank and Lines > Removal and Installation > Fuel Pump and Sender Unit.
4. Inspect the two vent line quick connectors inside the fuel tank (Figure 1) for looseness or damage. Reattach any loose connectors. If the connectors are damaged, replace the fuel tank. Refer to the WSM, Section 310-01 Fuel Tank and Lines > Removal and Installation > Fuel Tank.
